The Historical Museum of Bosnia and Herzegovina: Preservation of a  
Modernist Gem In Sarajevo

Department of Architectural Conservation

Czech Technical University in Prague | Faculty of Architecture

**DIPLOMA PROJECT**

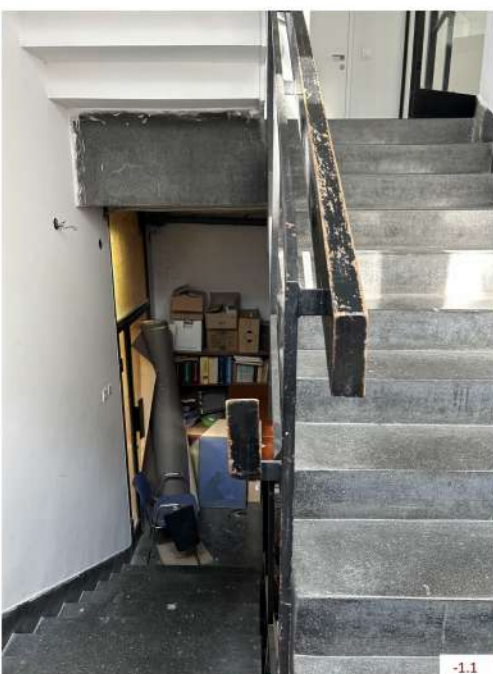
-1.1

- 1.1 Lack of storage; refurbishment of the stairs railing needed
- 1.2 Lack of storage; facilities not managed properly; door in poor condition
- 1.3 Lack of storage; refurbishing of walls and ceilings needed

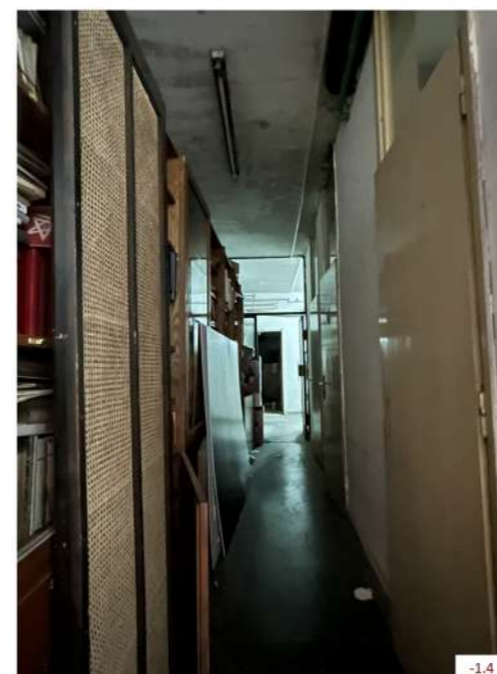
-1.4

- 1.4 Lack of storage; refurbishing of walls and ceilings needed; doors in poor condition
- 1.5 Lack of storage; refurbishing of walls, ceilings; facilities not managed properly; windows in poor condition

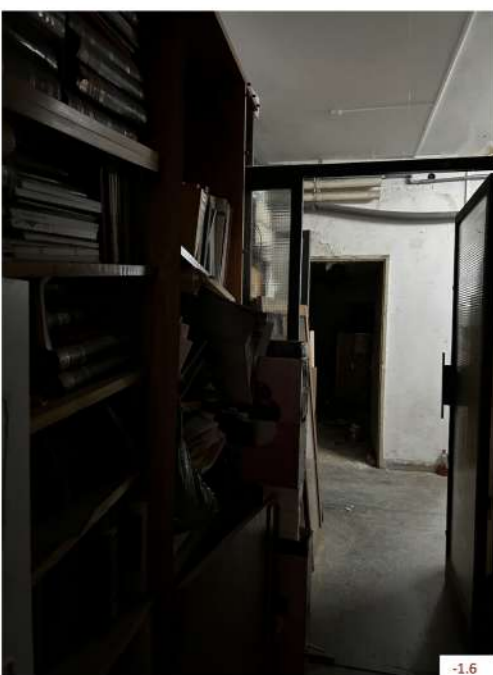
-1.6

- 1.6 Lack of storage; refurbishing of walls, ceilings, flooring; door in poor condition; facilities not managed properly
- 1.7 Lack of proper storage; refurbishing of walls, ceilings; windows in poor condition; facilities not managed properly

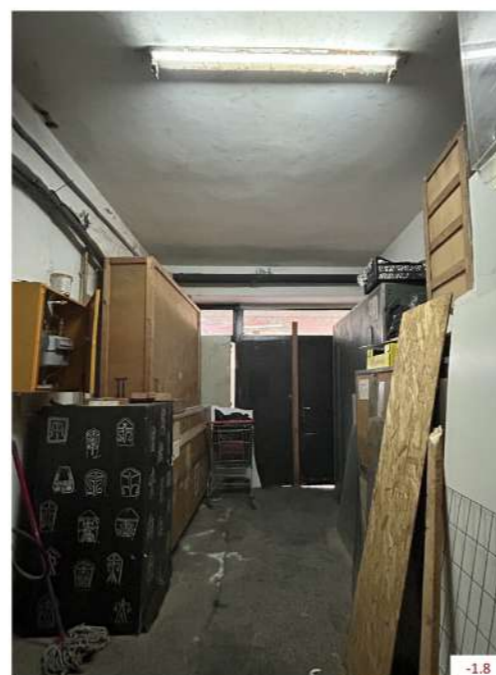
-1.8

- 1.8 Lack of storage; refurbishing of walls, ceilings, flooring; door in poor condition; facilities not managed properly
- 1.9 Refurbishing of walls, ceilings, flooring; facilities not managed properly

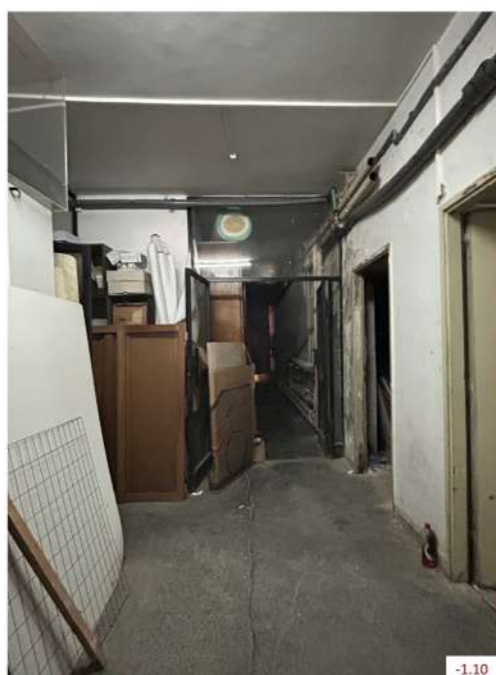
-1.10

- 1.10 Lack of storage; refurbishing of walls, ceilings, flooring; door in poor condition; facilities not managed properly
- 1.11 Solving the cause of the problem outside (the room is below the Museum entrance platform), refurbishment of the whole room

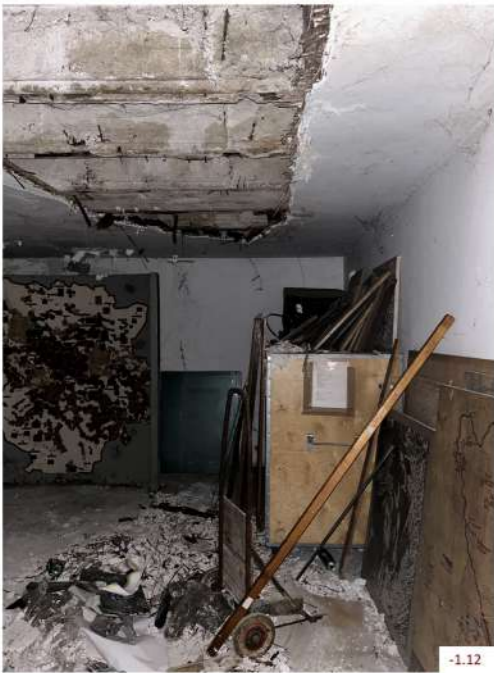
-1.12

- 1.12 Solving the cause of the problem outside (the room is below the Museum entrance platform), refurbishment of the whole room
- 1.13 Lack of storage; facilities in poor condition; refurbishing of walls, ceilings and flooring
- 1.14 Lack of storage; refurbishing of flooring; discontinued refurbishment of the area
- 1.15 Refurbishment of flooring
- 1.16 Refurbishment of flooring
- 1.17 Refurbishment of flooring
- 1.18 Refurbishment of flooring
- 1.19 Satisfactory state
- 1.20 Refurbishing of flooring; doors and windows in poor condition
- 1.21 refurbishment of stairs, flooring; doors and windows in poor condition; lack of proper exhibition space for the exhibits
- 1.22 Refurbishment of stairs, flooring; doors and windows in poor condition; lack of proper exhibition space for the exhibits

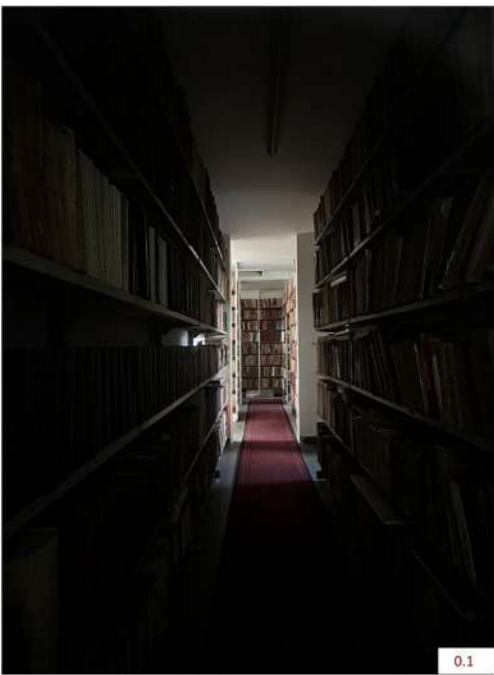
- 0.1 Satisfactory state; lack of storage
- 0.2 Satisfactory state; refurbishment of doors
- 0.3 Flooring refurbishment, doors in poor condition
- 0.4 Flooring refurbishment, doors and windows in poor condition
- 0.5 Flooring refurbishment, doors and windows in poor condition
- 0.6 Lack of storage; refurbishing of walls, ceilingss, flooring; door in poor condition; facilities not managed properly
- 0.7 Flooring refurbishment, doors and windows in poor condition
- 0.8 Flooring refurbishment, doors and windows in poor condition
- 0.9 Flooring refurbishment, doors and windows in poor condition
- 0.10 Flooring refurbishment, doors and windows in poor condition
- 0.11 Satisfactory state

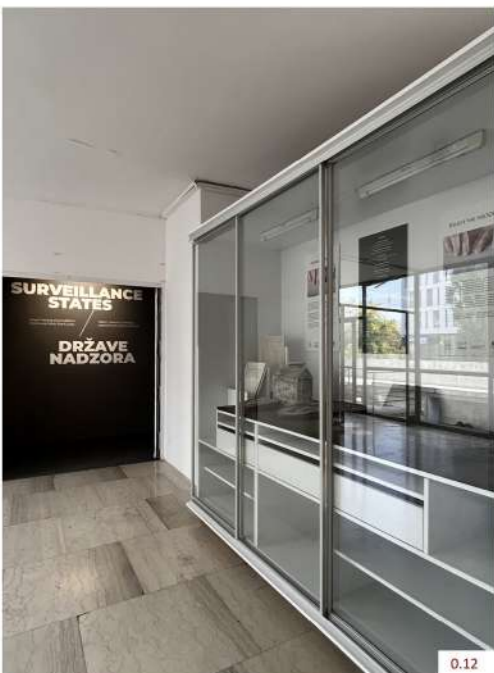
- 0.12 Satisfactory state
- 0.13 Satisfactory state; windows in poor condition
- 0.14 Satisfactory state
- 0.15 Satisfactory state
- 0.16 Satisfactory state; windows in poor condition
- 0.17 Satisfactory state; windows in poor condition
- 0.18 Satisfactory state; windows in poor condition; refurbishment of facilities
- 0.19 Satisfactory state; windows in poor condition
- 0.20 Windows in poor condition; stone elements in poor state
- 0.21 Windows and doors in poor condition, refurbishment of the bottom of the "floating cube" refurbishment of greenery
- 0.22 Windows and doors in poor condition, refurbishment of the bottom of the "floating cube" refurbishment of greenery

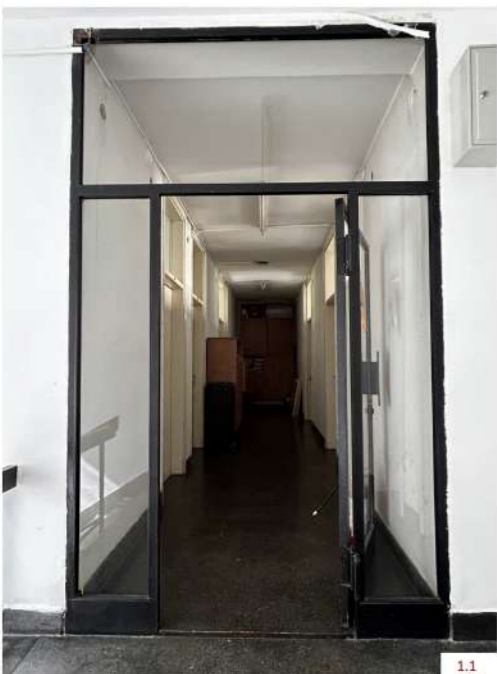
- 1.1 Corridor and offices to which it leads could benefit from full refurbishment
- 1.2 Stair railing refurbishment; facilities not properly managed
- 1.3 Satisfactory state
- 1.4 Satisfactory state
- 1.5 Satisfactory state; managing storage behind the curtain and providing more exhibition space
- 1.6 Satisfactory state; windows are new not matching the original appearance
- 1.7 Stair railing refurbishment, windows in poor condition
- 1.8 Satisfactory state
- 1.9 Satisfactory state; windows are new not matching the original appearance
- 1.10 Stairs and stair railing refurbishment; windows in poor condition
- 1.11 Satisfactory state

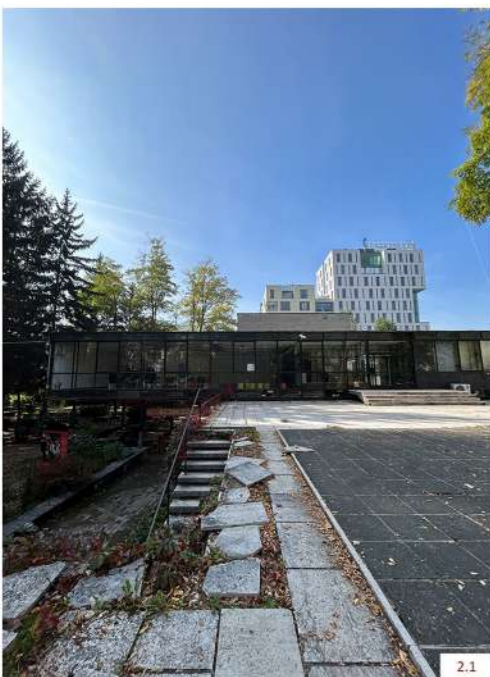
2.1 Damaged platform and stairs

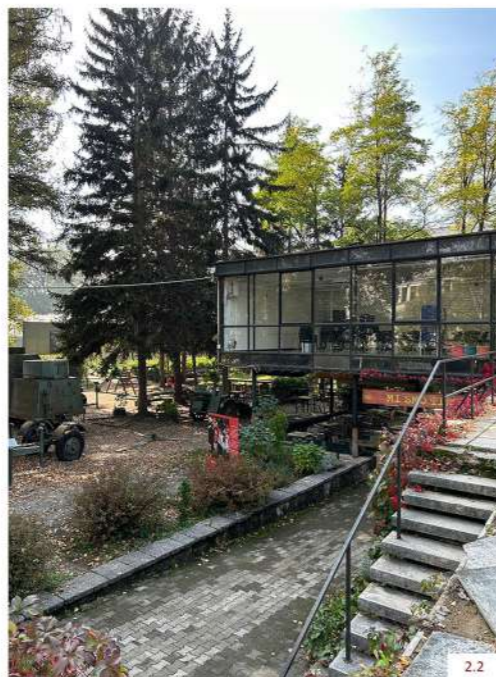
2.2 Exhibits unprotected in the open; greenery covering the stairs

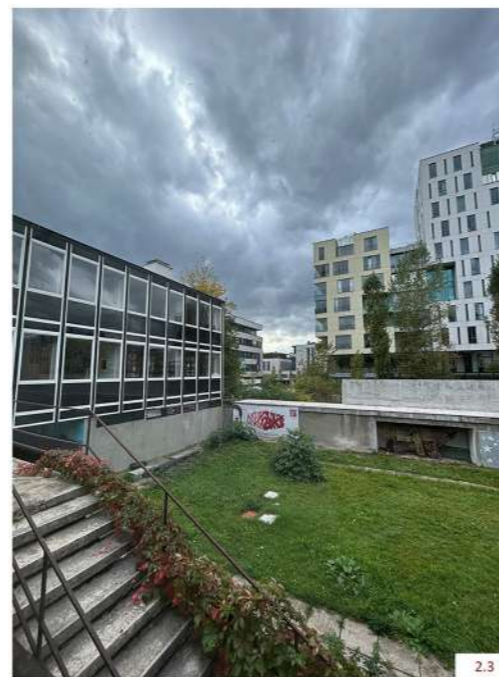
2.3 Damaged stairs to the courtyard; neglected courtyard and stone panels missing from the courtyard wall

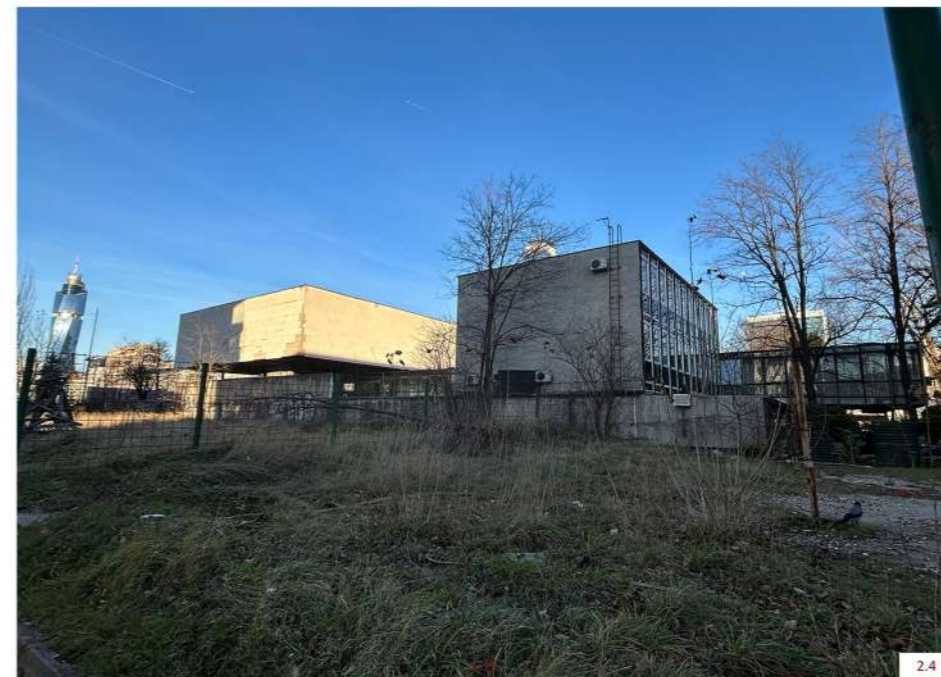
2.4 Damaged wall of the courtyard; fenced greenery part neglected; façade damage - danger of stone panels falling from the cube

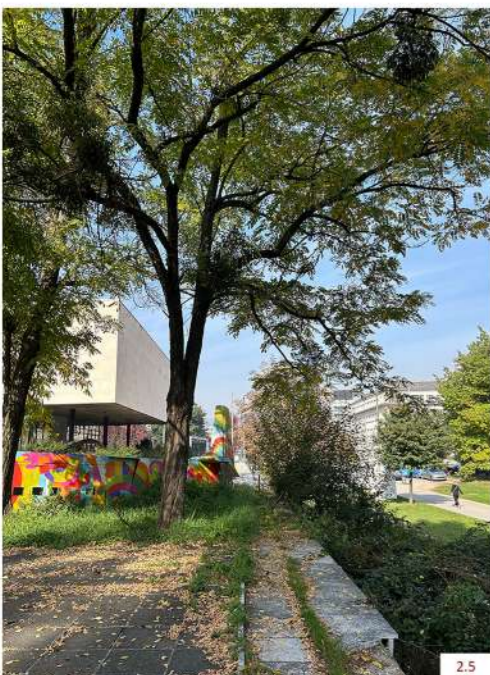
2.5 Platform damage and unplanned greenery

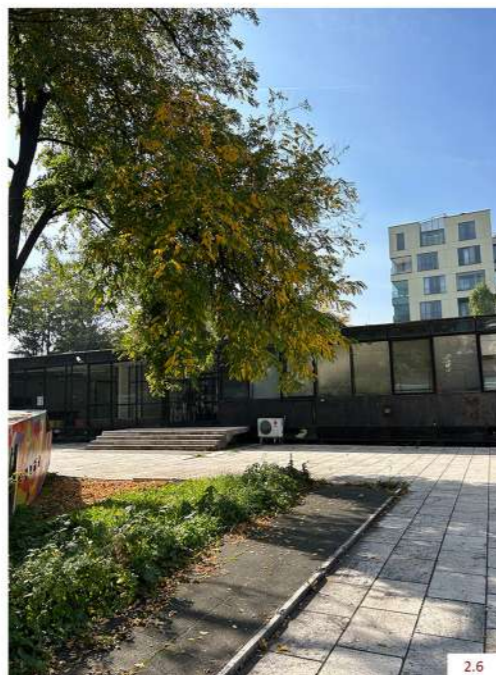
2.6 Greenery not in the original plan, possibly harming the structure

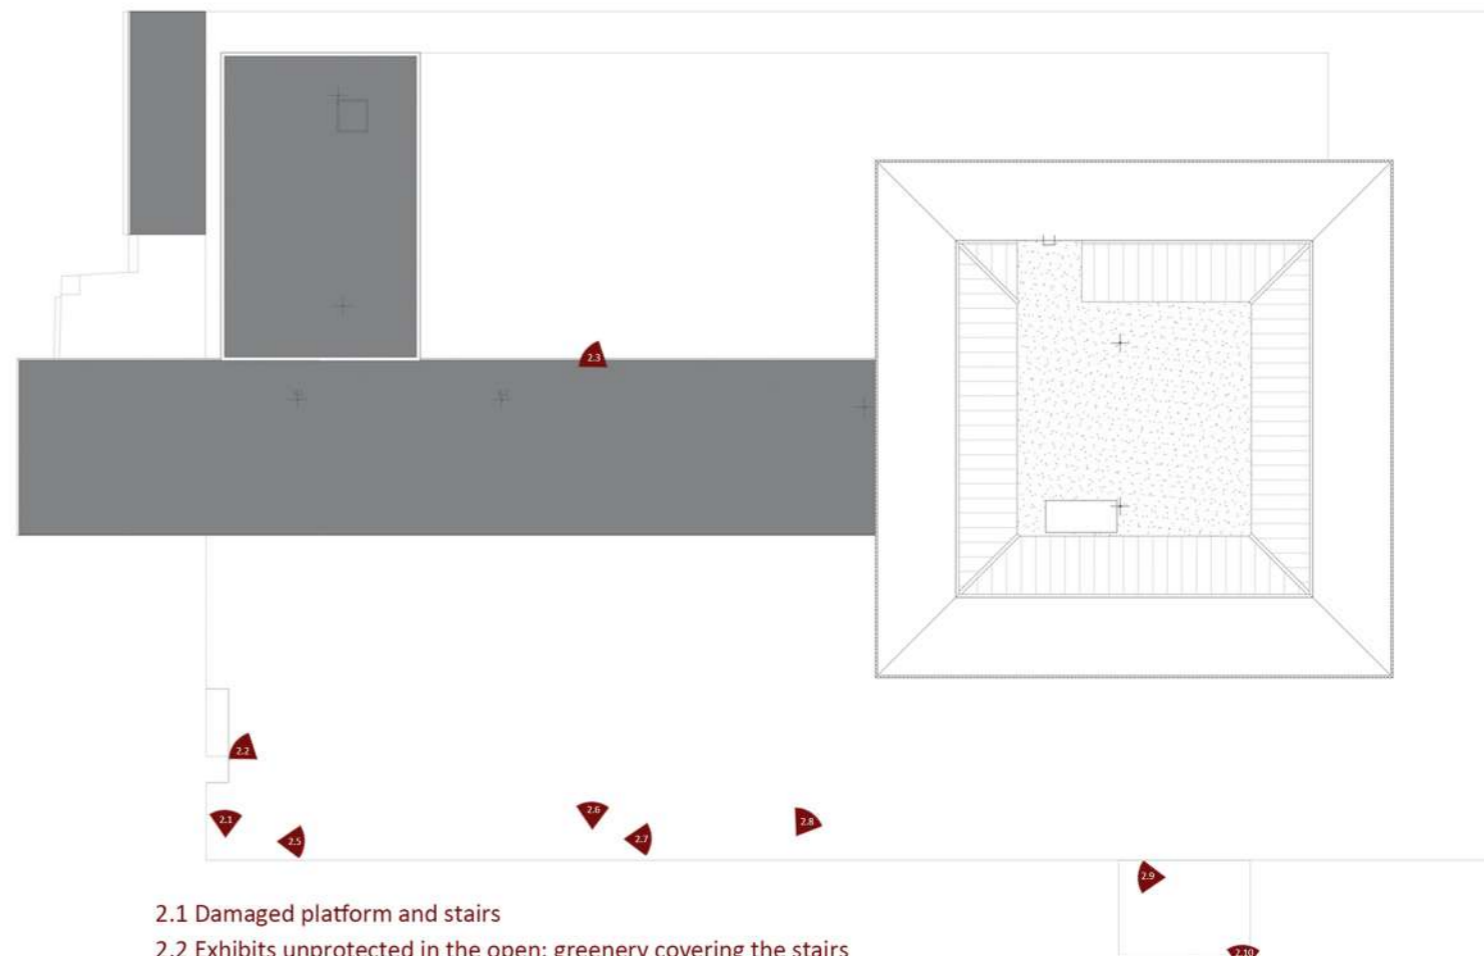
2.8 Façade in poor condition; missing and broken stone panels; broken parts of glass; rusty metal elements

2.9 Main entrance stairs damaged and missing parts

2.10 Main stairs dangerously ruined; stone panels broken

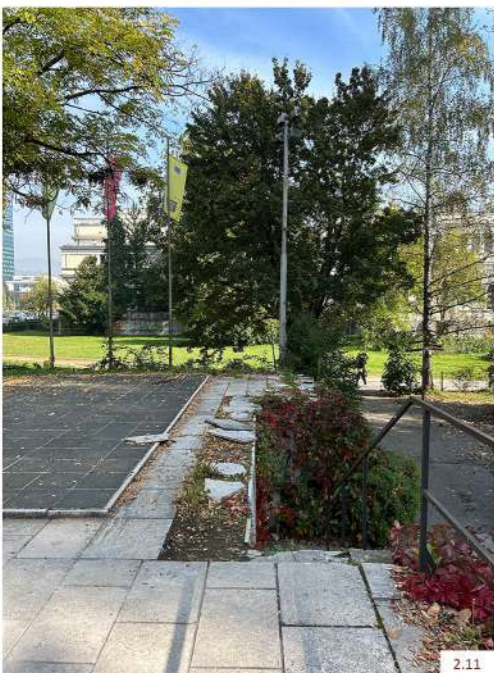
- 2.11 Greenery damage of the structure; platform does not have original appearance; paving ruined
- 2.12 Exhibits in the open space, unprotected
- 2.13 Windows in poor condition

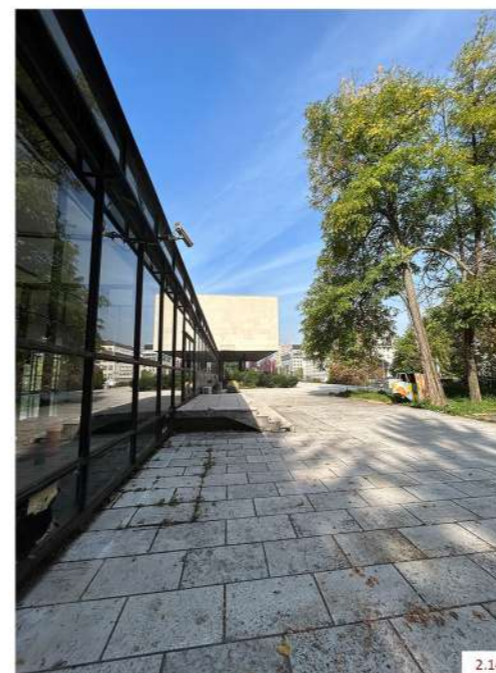
- 2.14 Broken glass elements, doors and windows in poor condition; grass growing from pavement; stairs damaged
- 2.15 Broken glass elements; grass growing from pavement

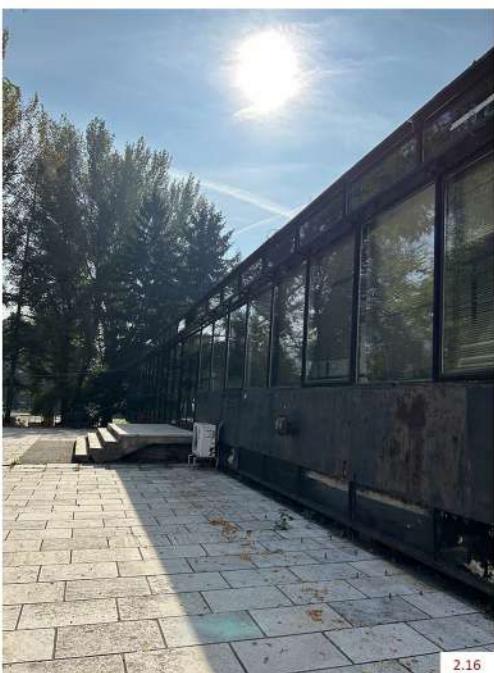
- 2.16 Rusty metal façade elements, windows in poor condition; broken glass elements; differences in pavement; stairs damaged
- 2.17 Rusty metal elements; broken glass elements; air conditioning unified and placed without coordination; flower pots in poor condition

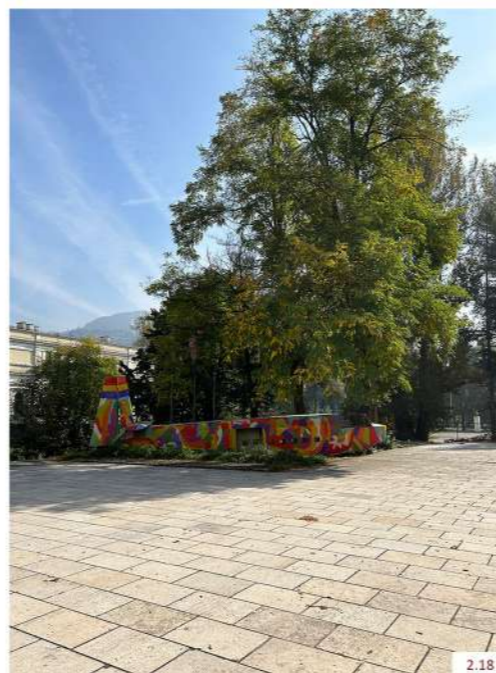
- 2.18 Greenery on the platform
- 2.19 Highly damaged main entrance stairs with breakages and missing parts
- 2.20 Damage on the façade (stone elements; plaster; marble); difference in pavement; lack of storage

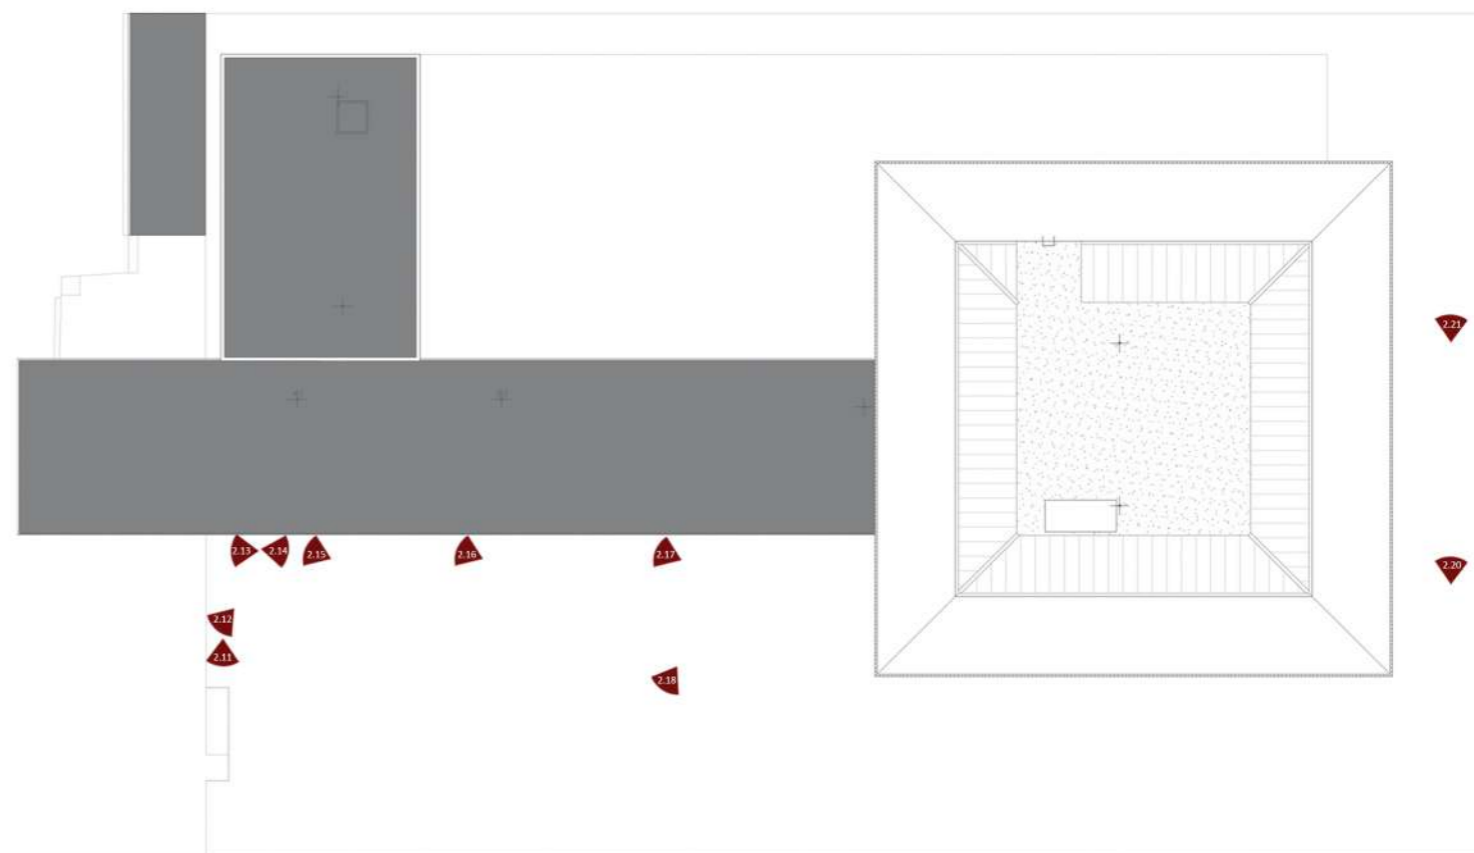
- 2.21 Damage on the street-facing-wall on both sides (stone panels); damaged pavement

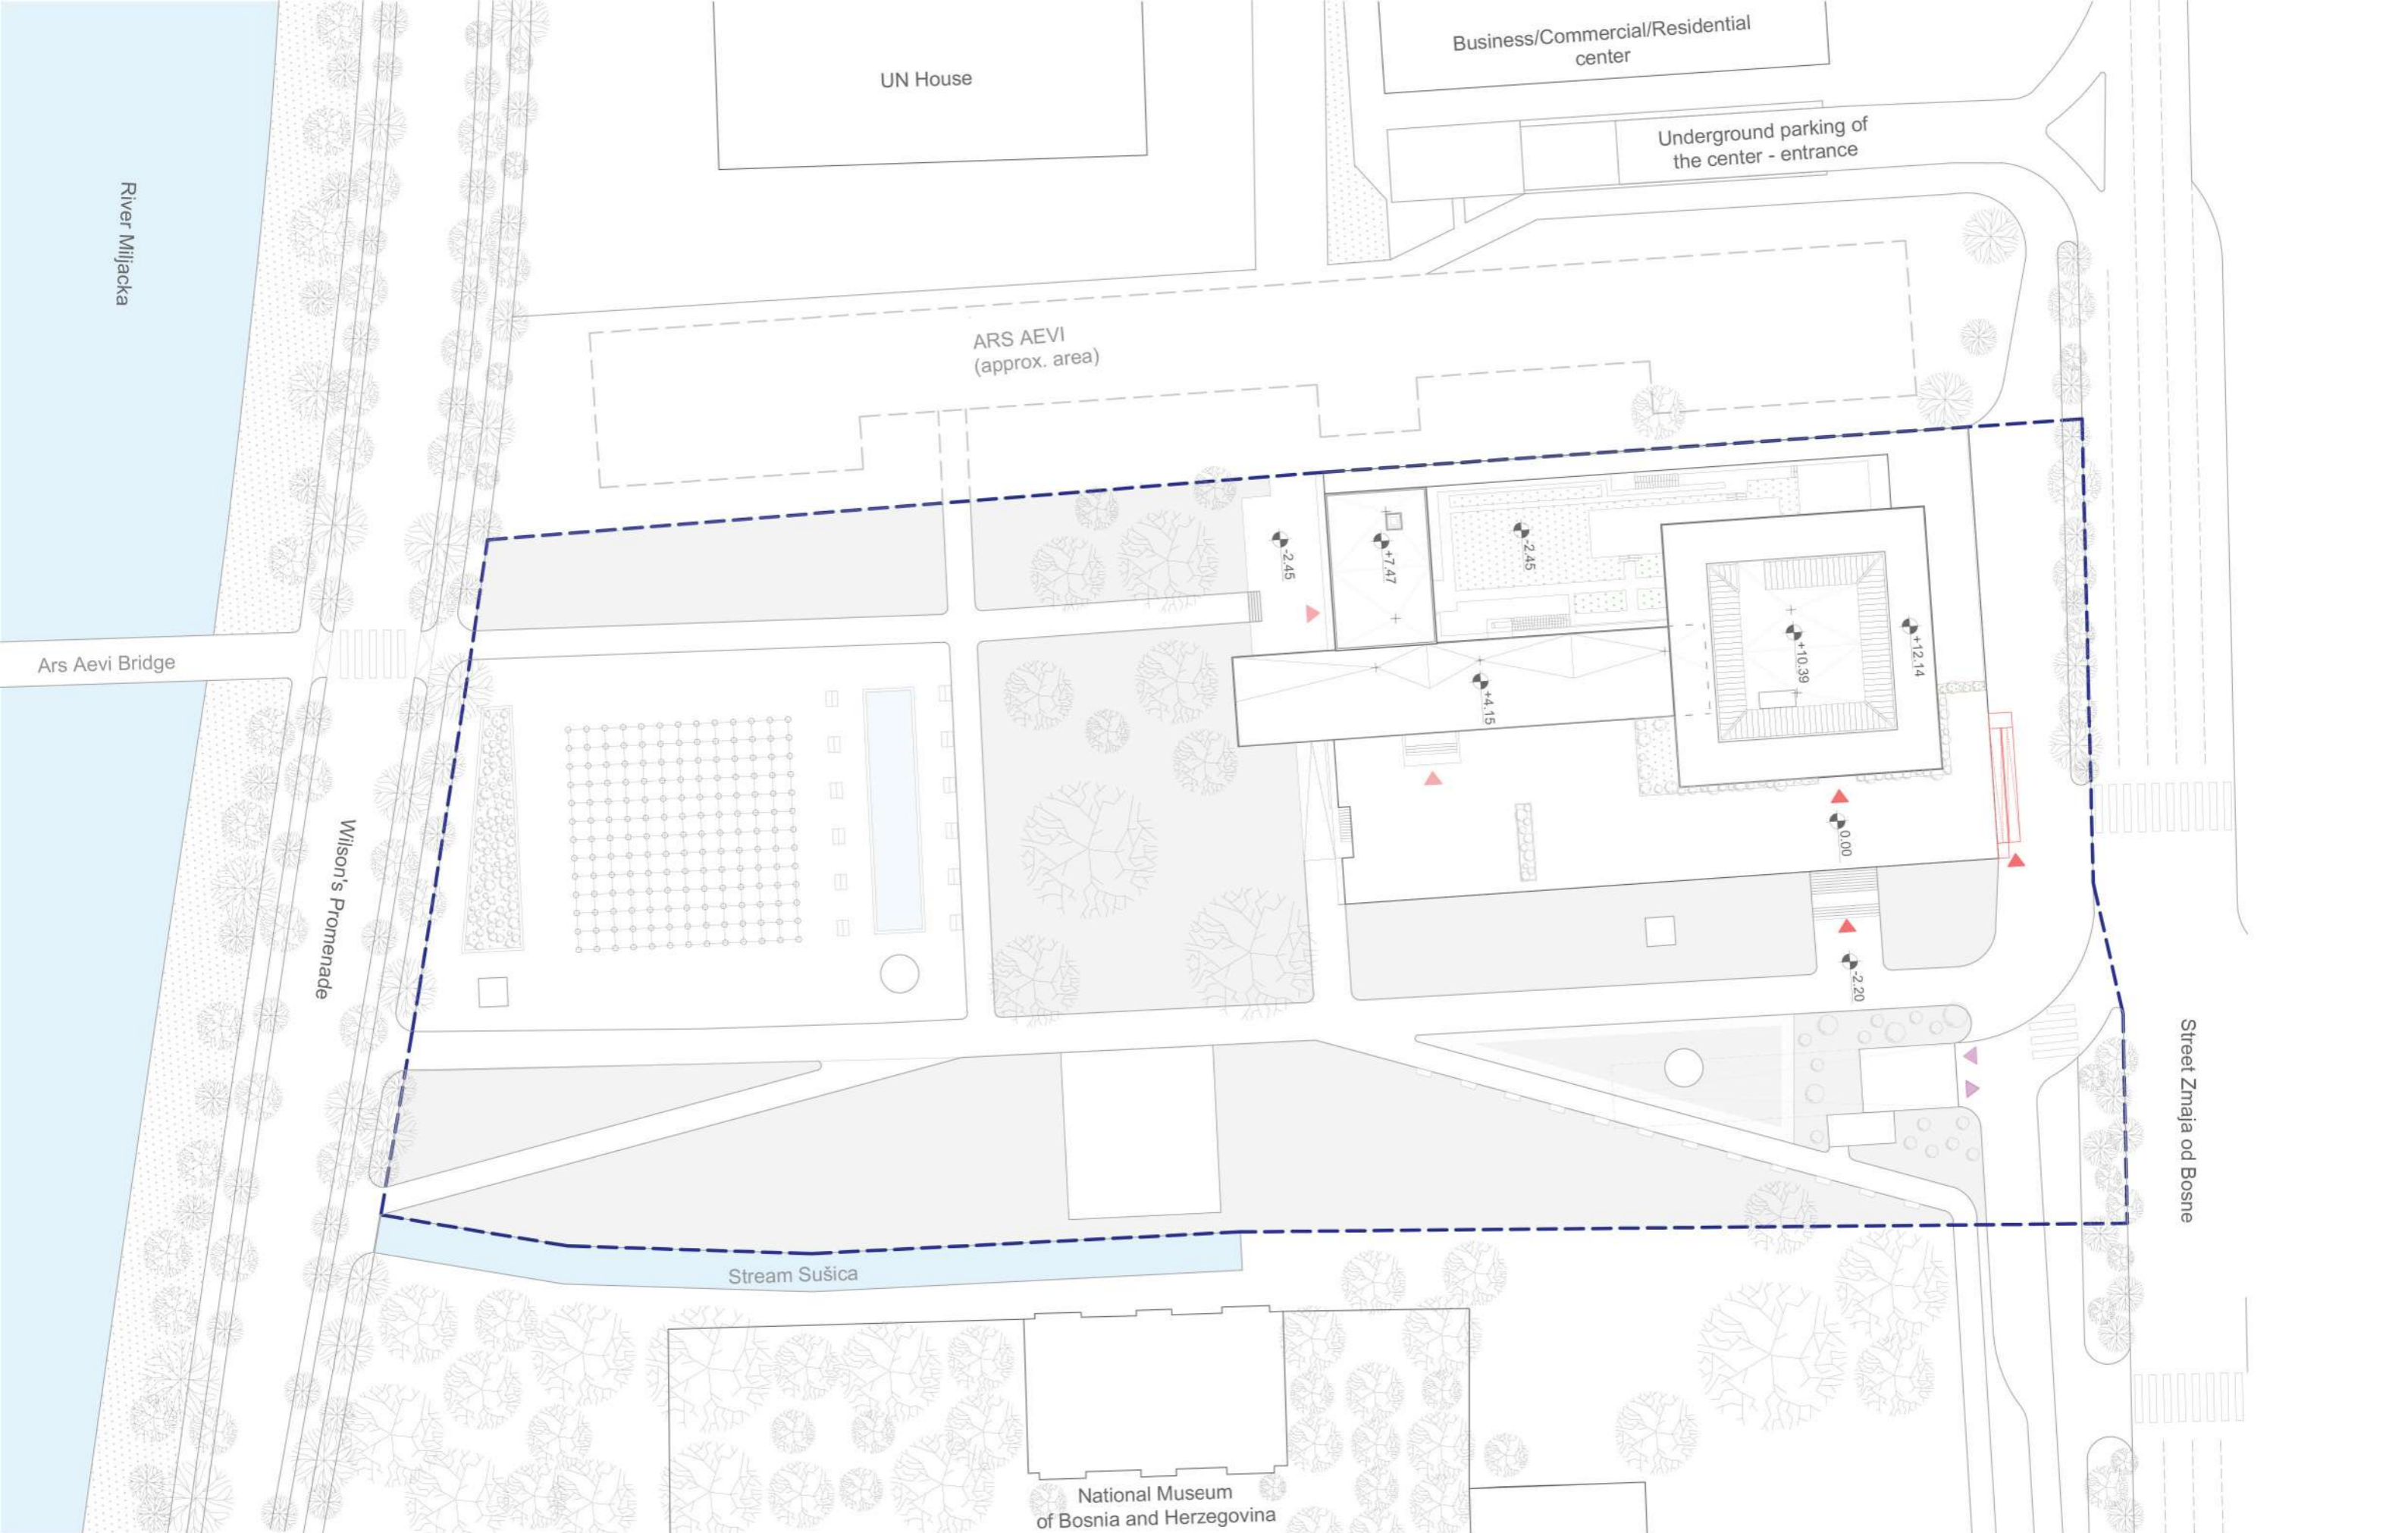
Site plan - new state

◀ Main way to enter the building

◀ Secondary entrances

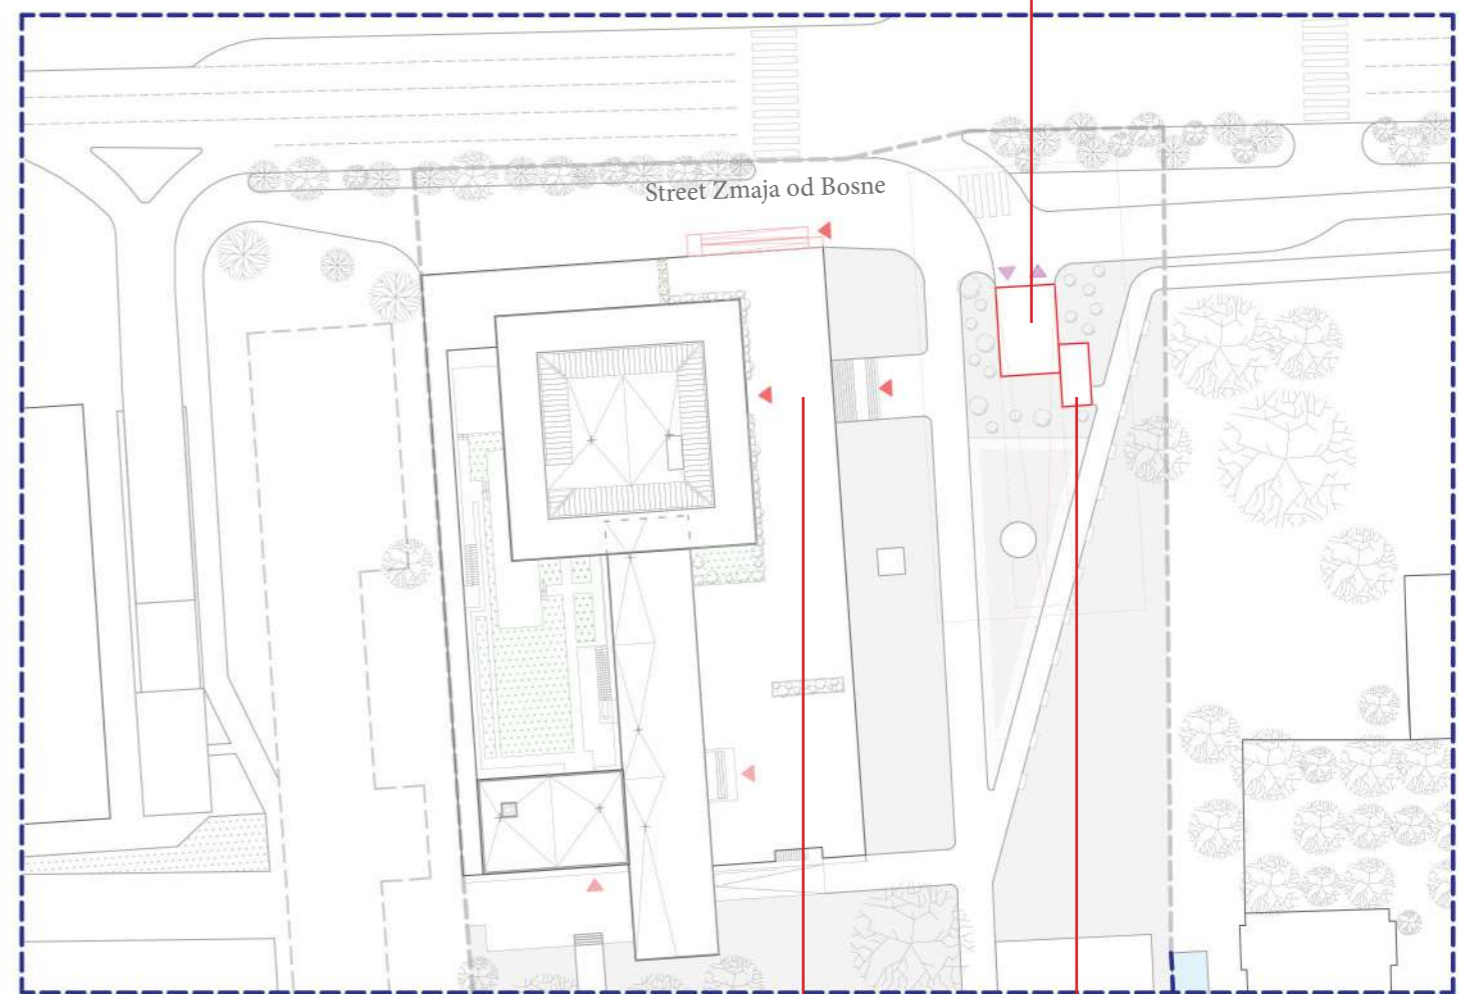
Entrance/Exit of the the underground parking

Main entrance to the building

Proposed position of entrance to the underground parking
