The Historical Museum of Bosnia and Herzegovina: Preservation of a  
Modernist Gem In Sarajevo

Department of Architectural Conservation

Czech Technical University in Prague | Faculty of Architecture

**DIPLOMA PROJECT**

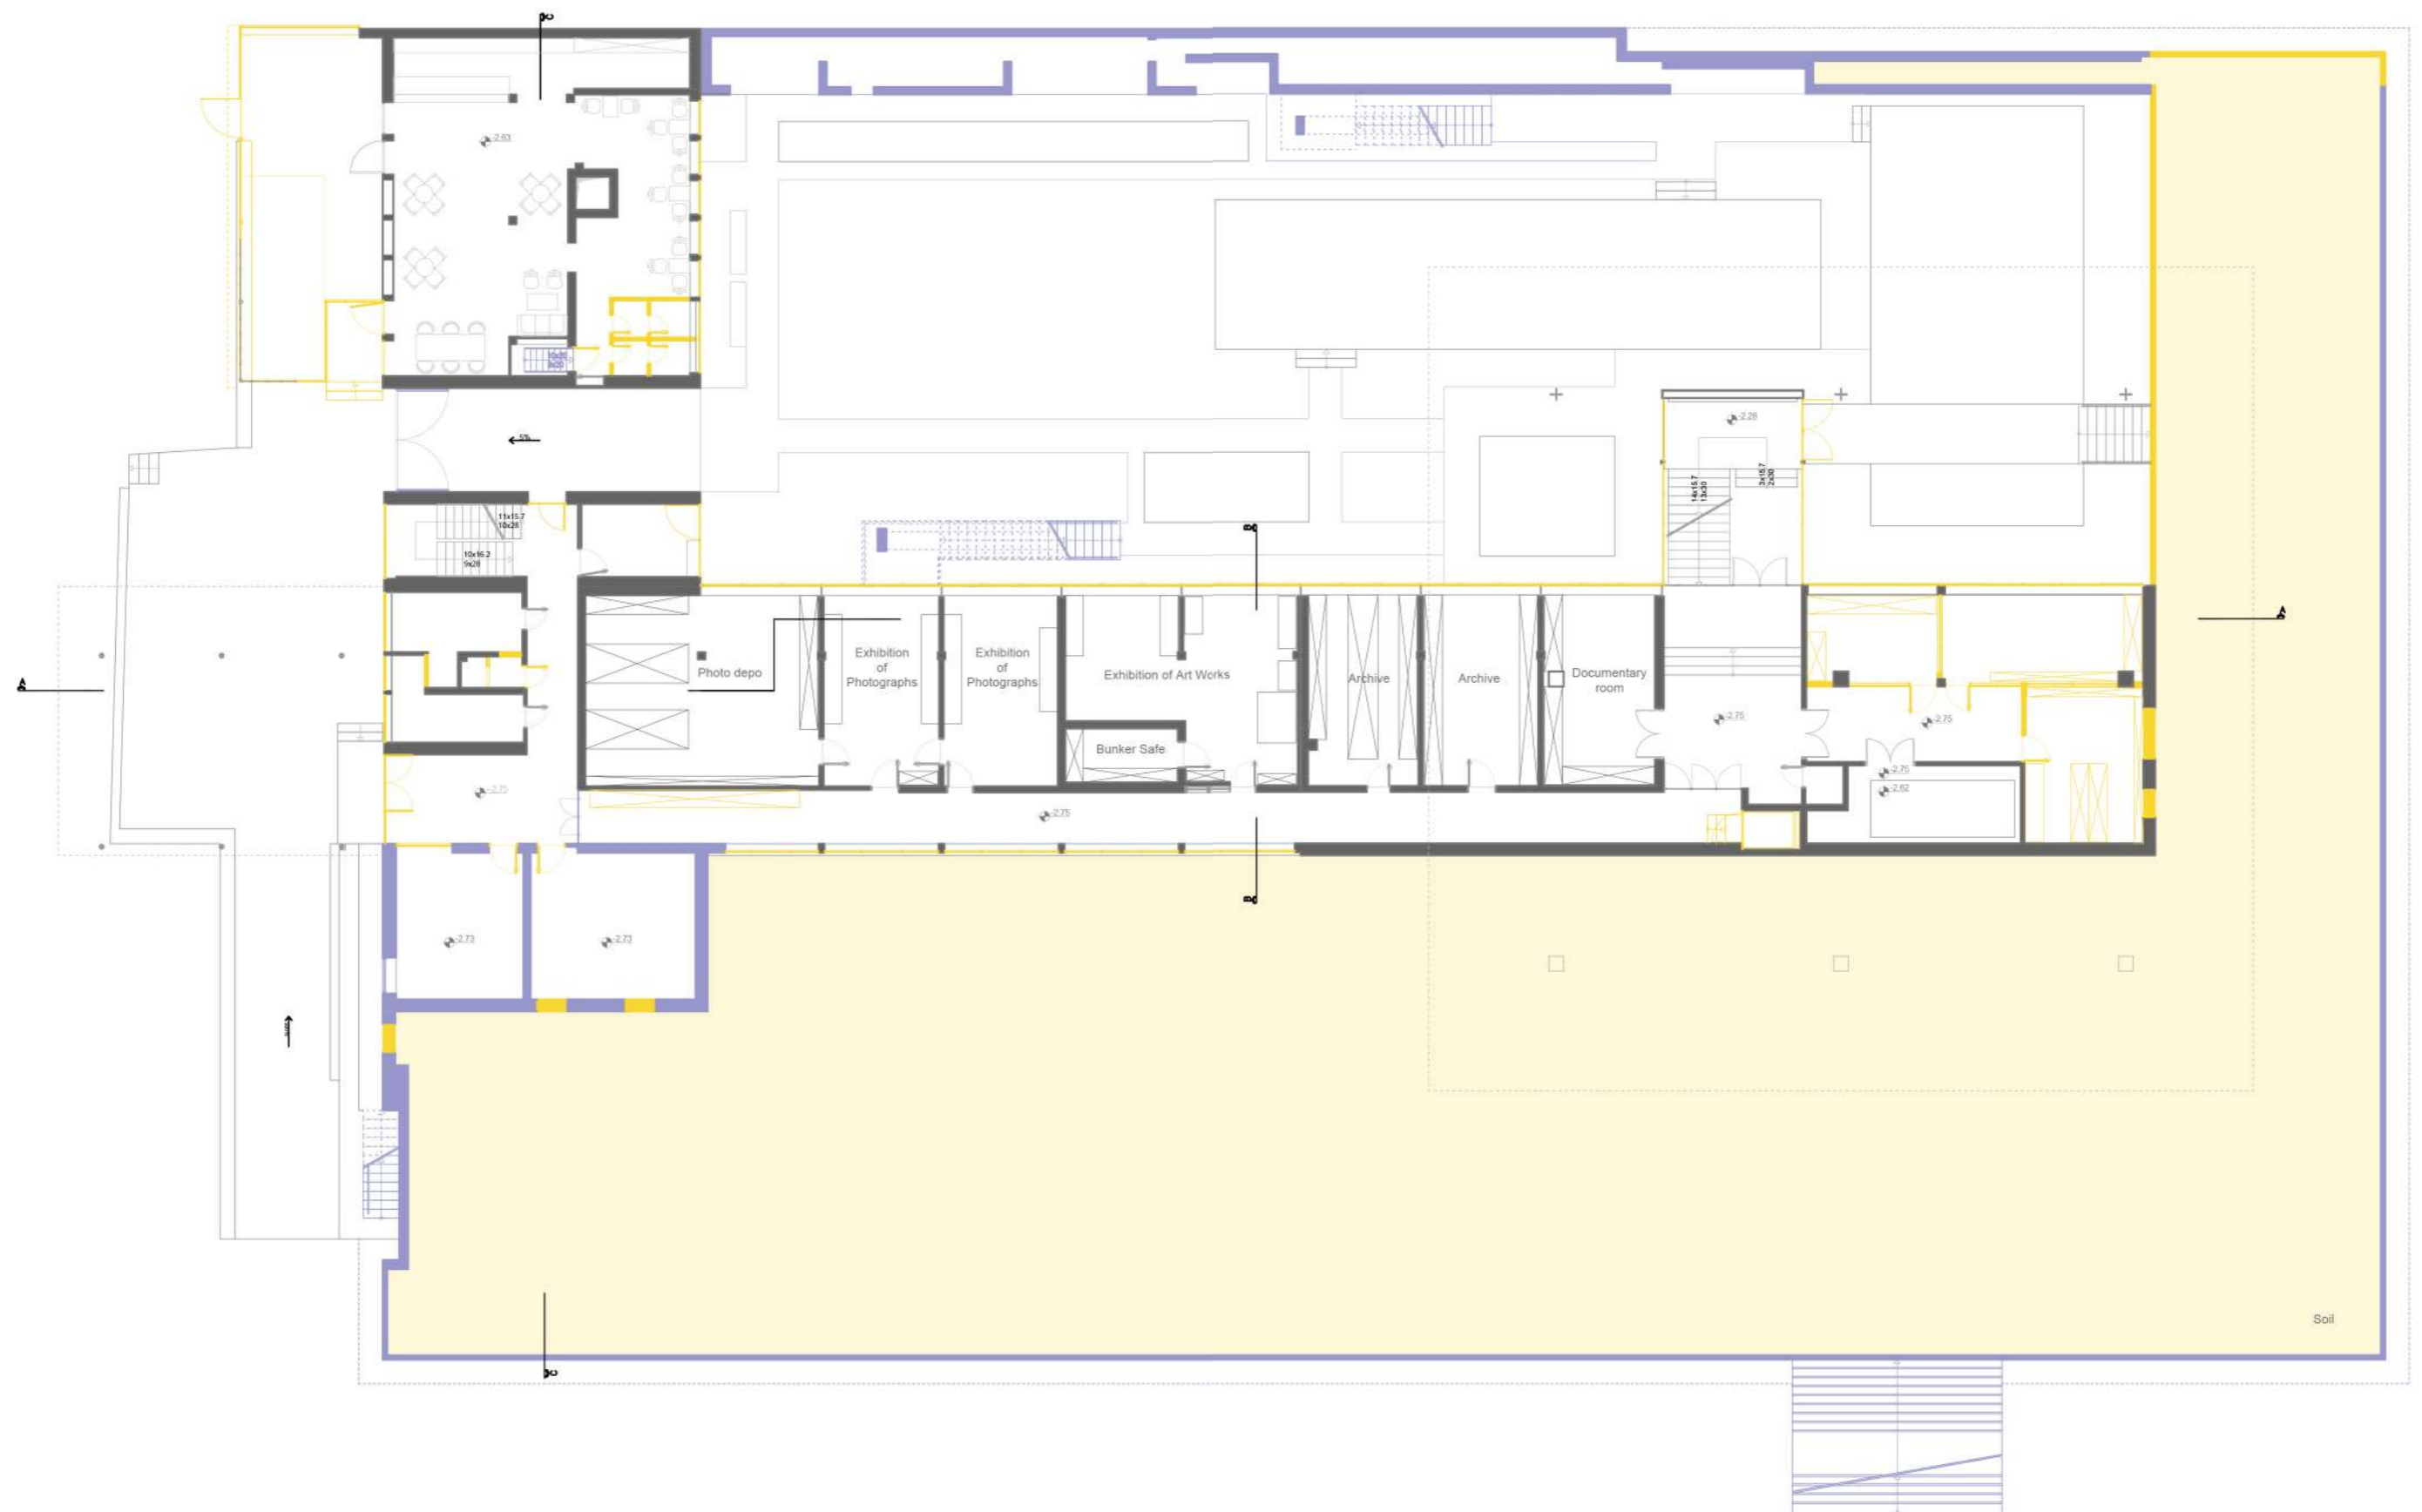
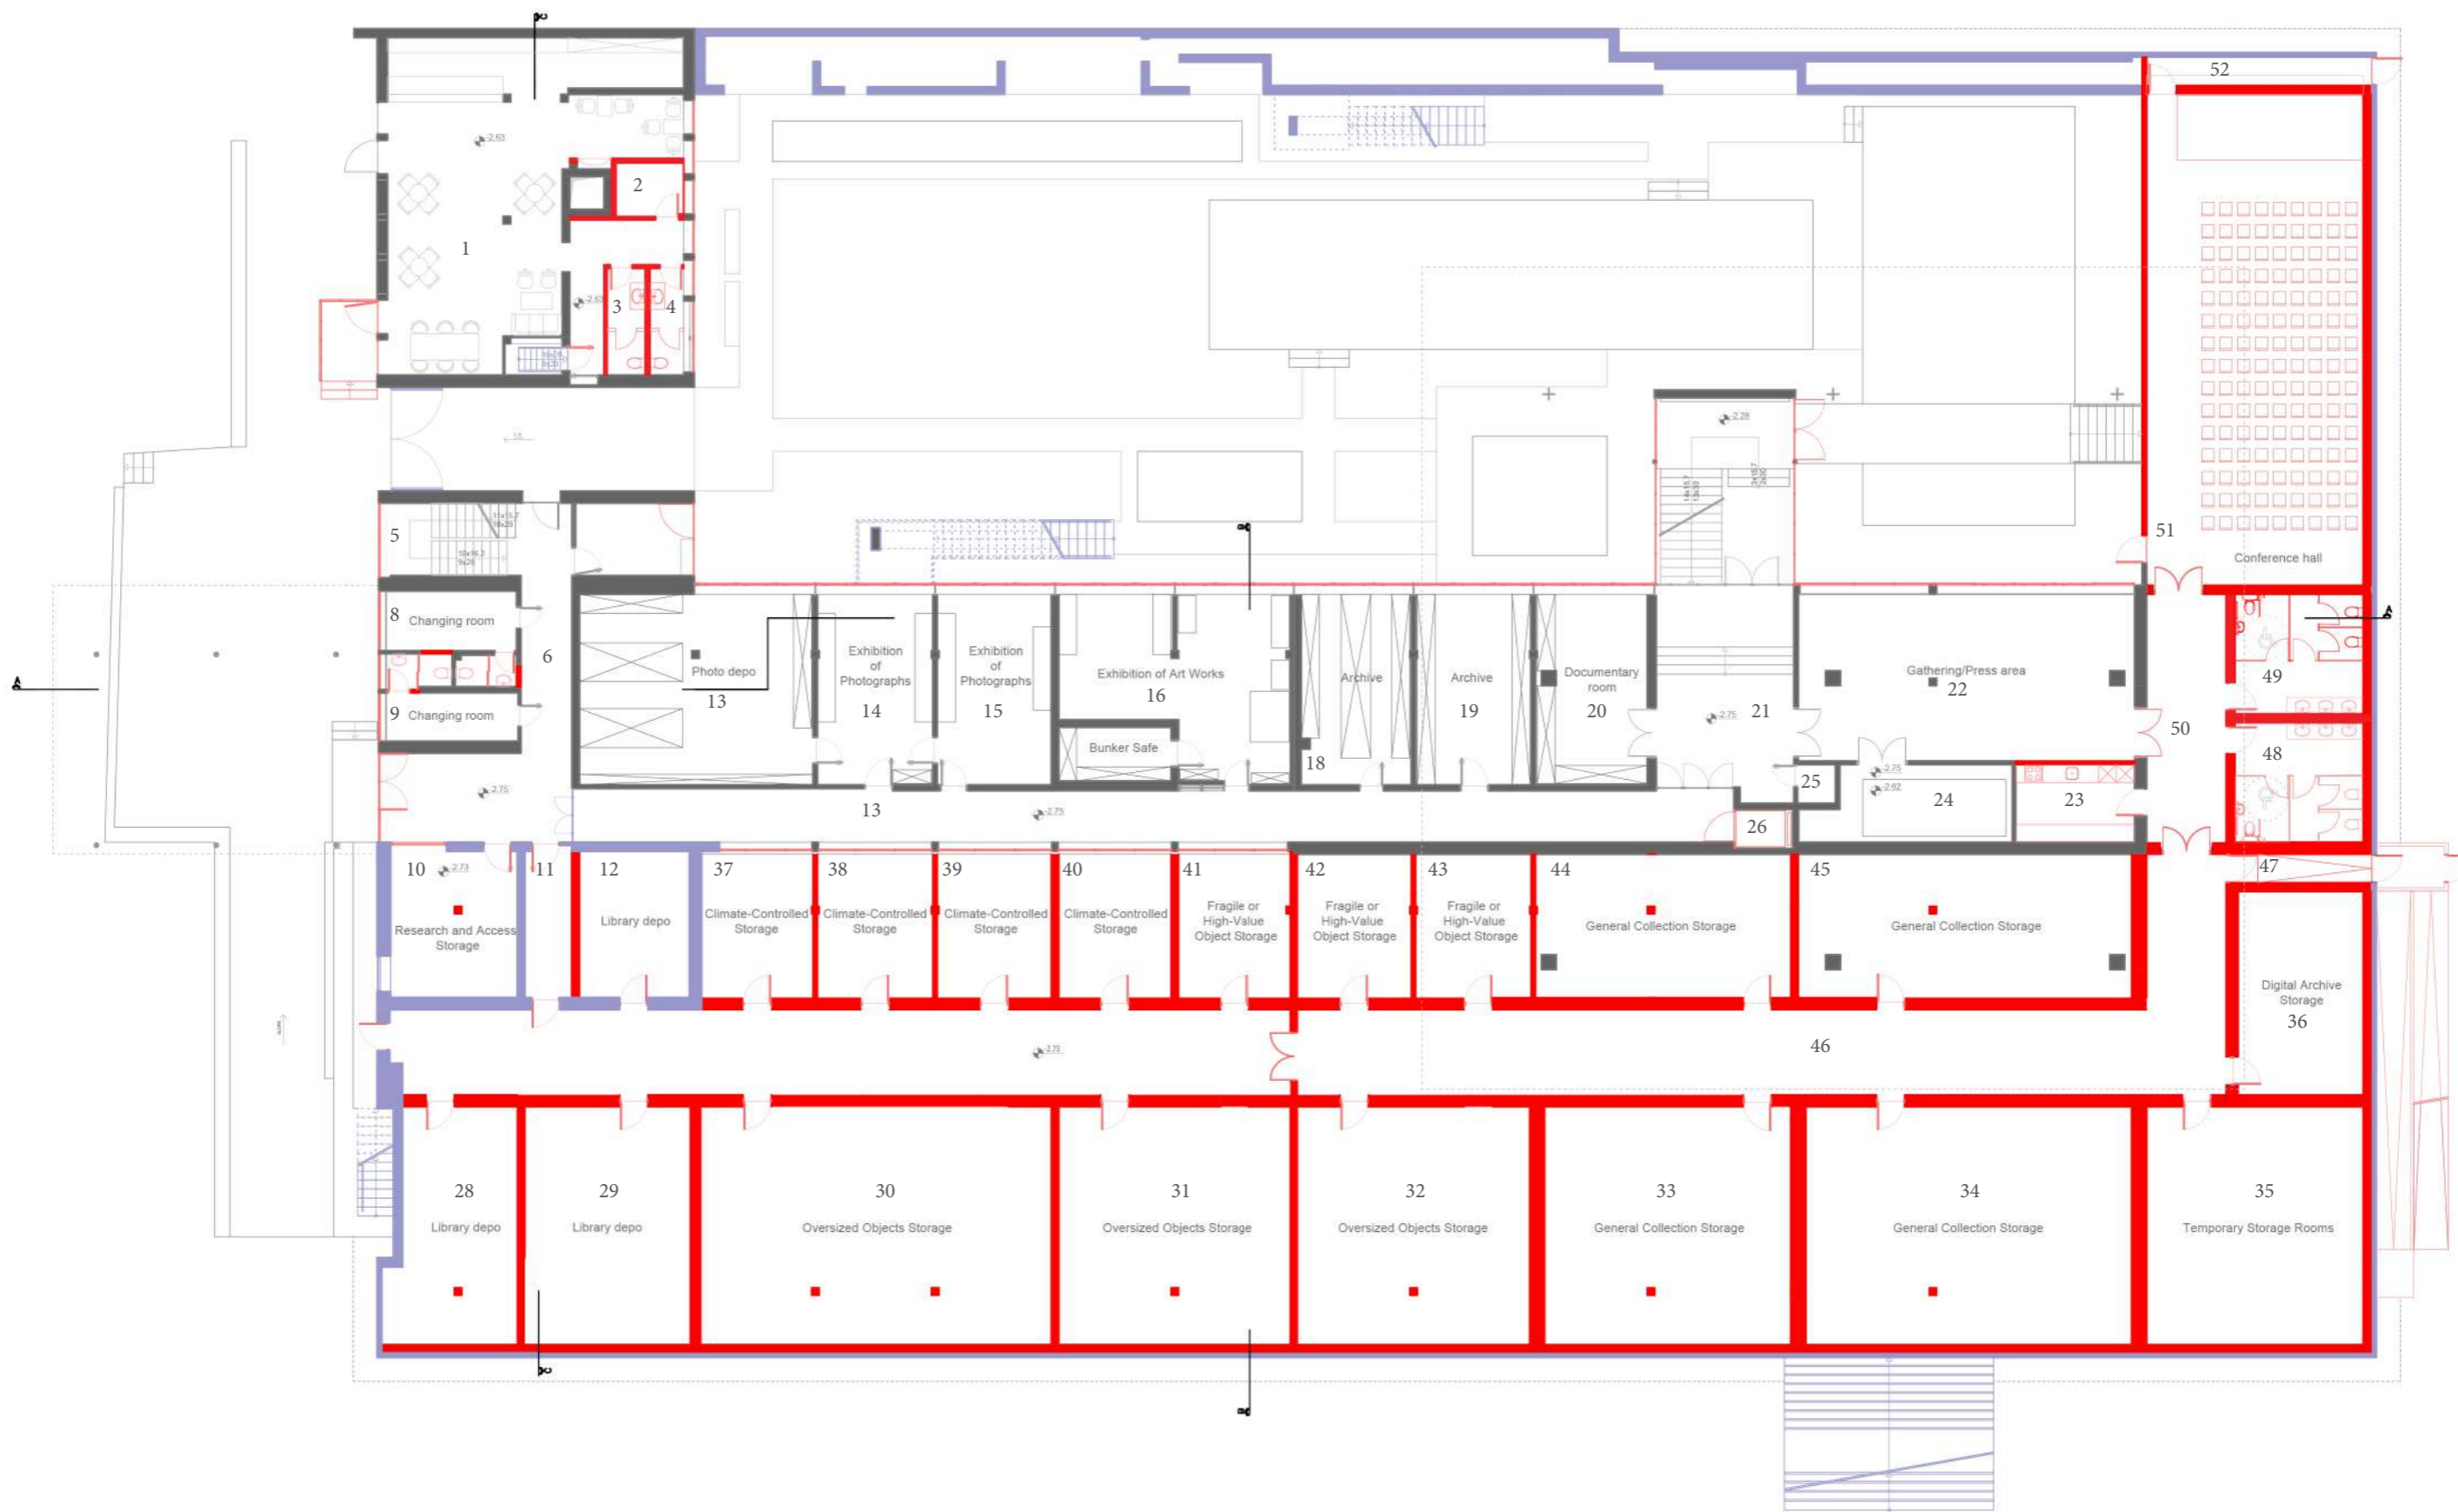
Basement floor plan - new state

No	Name	Area (m2)
<b>Existing part</b>		
1	Multifunctional area for rent	56,50
2	Toilet without barriers	4,00
3	Toilet 1	3,90
4	Toilet 2	3,90
5	Staircase	2,30
6	Staircase / Hallway	44,10
7	Storage	9,50
8	Changing room	9,00
9	Changing room	7,30
10	Research and access storage	21,10
11	Corridor	7,60
12	Library depo	18,00
13	Photo depo	49,8
14	Exhibition of photographs	24,4
15	Exhibition of photographs	24,10
16	Exhibition of art works	39,80
17	Bunker safe	6,90
18	Archive	23,50
19	Documentary center	24,60
20	Documentary center	22,75
21	Hall	31,70
22	Gathering/Press area	62,58
23	Kitchen for catering serving preparation	10,32
24	Technical room	16,49
25	Storage	1,65
26	Elevator	2,25
27	Corridor	69,50
<b>New part</b>		
28	Library depo	31,81
29	Library depo	43,74
30	Oversized objects storage	93,00
31	Oversized objects storage	61,75
32	Oversized objects storage	61,75
33	General collection storage	65,41
34	General collection storage	86,06

35	Temporary storage room	57,13
36	Digital storage	28,45
37	Climate-controlled storage	18,28
38	Climate-controlled storage	18,89
39	Climate-controlled storage	18,64
40	Climate-controlled storage	18,40
41	Fragile or high-value object storage	18,40
42	Fragile or high-value object storage	18,31
43	Fragile or high-value object storage	18,50
44	General collection storage	40,55
45	General collection storage	52,91
46	Corridor	188,85
47	Escape exit 1	4,43
48	Toilets Female	17,14
49	Toilets Male	17,14
50	Corridor	22,08
51	Conference hall	118,95
52	Escape exit 2	7,15

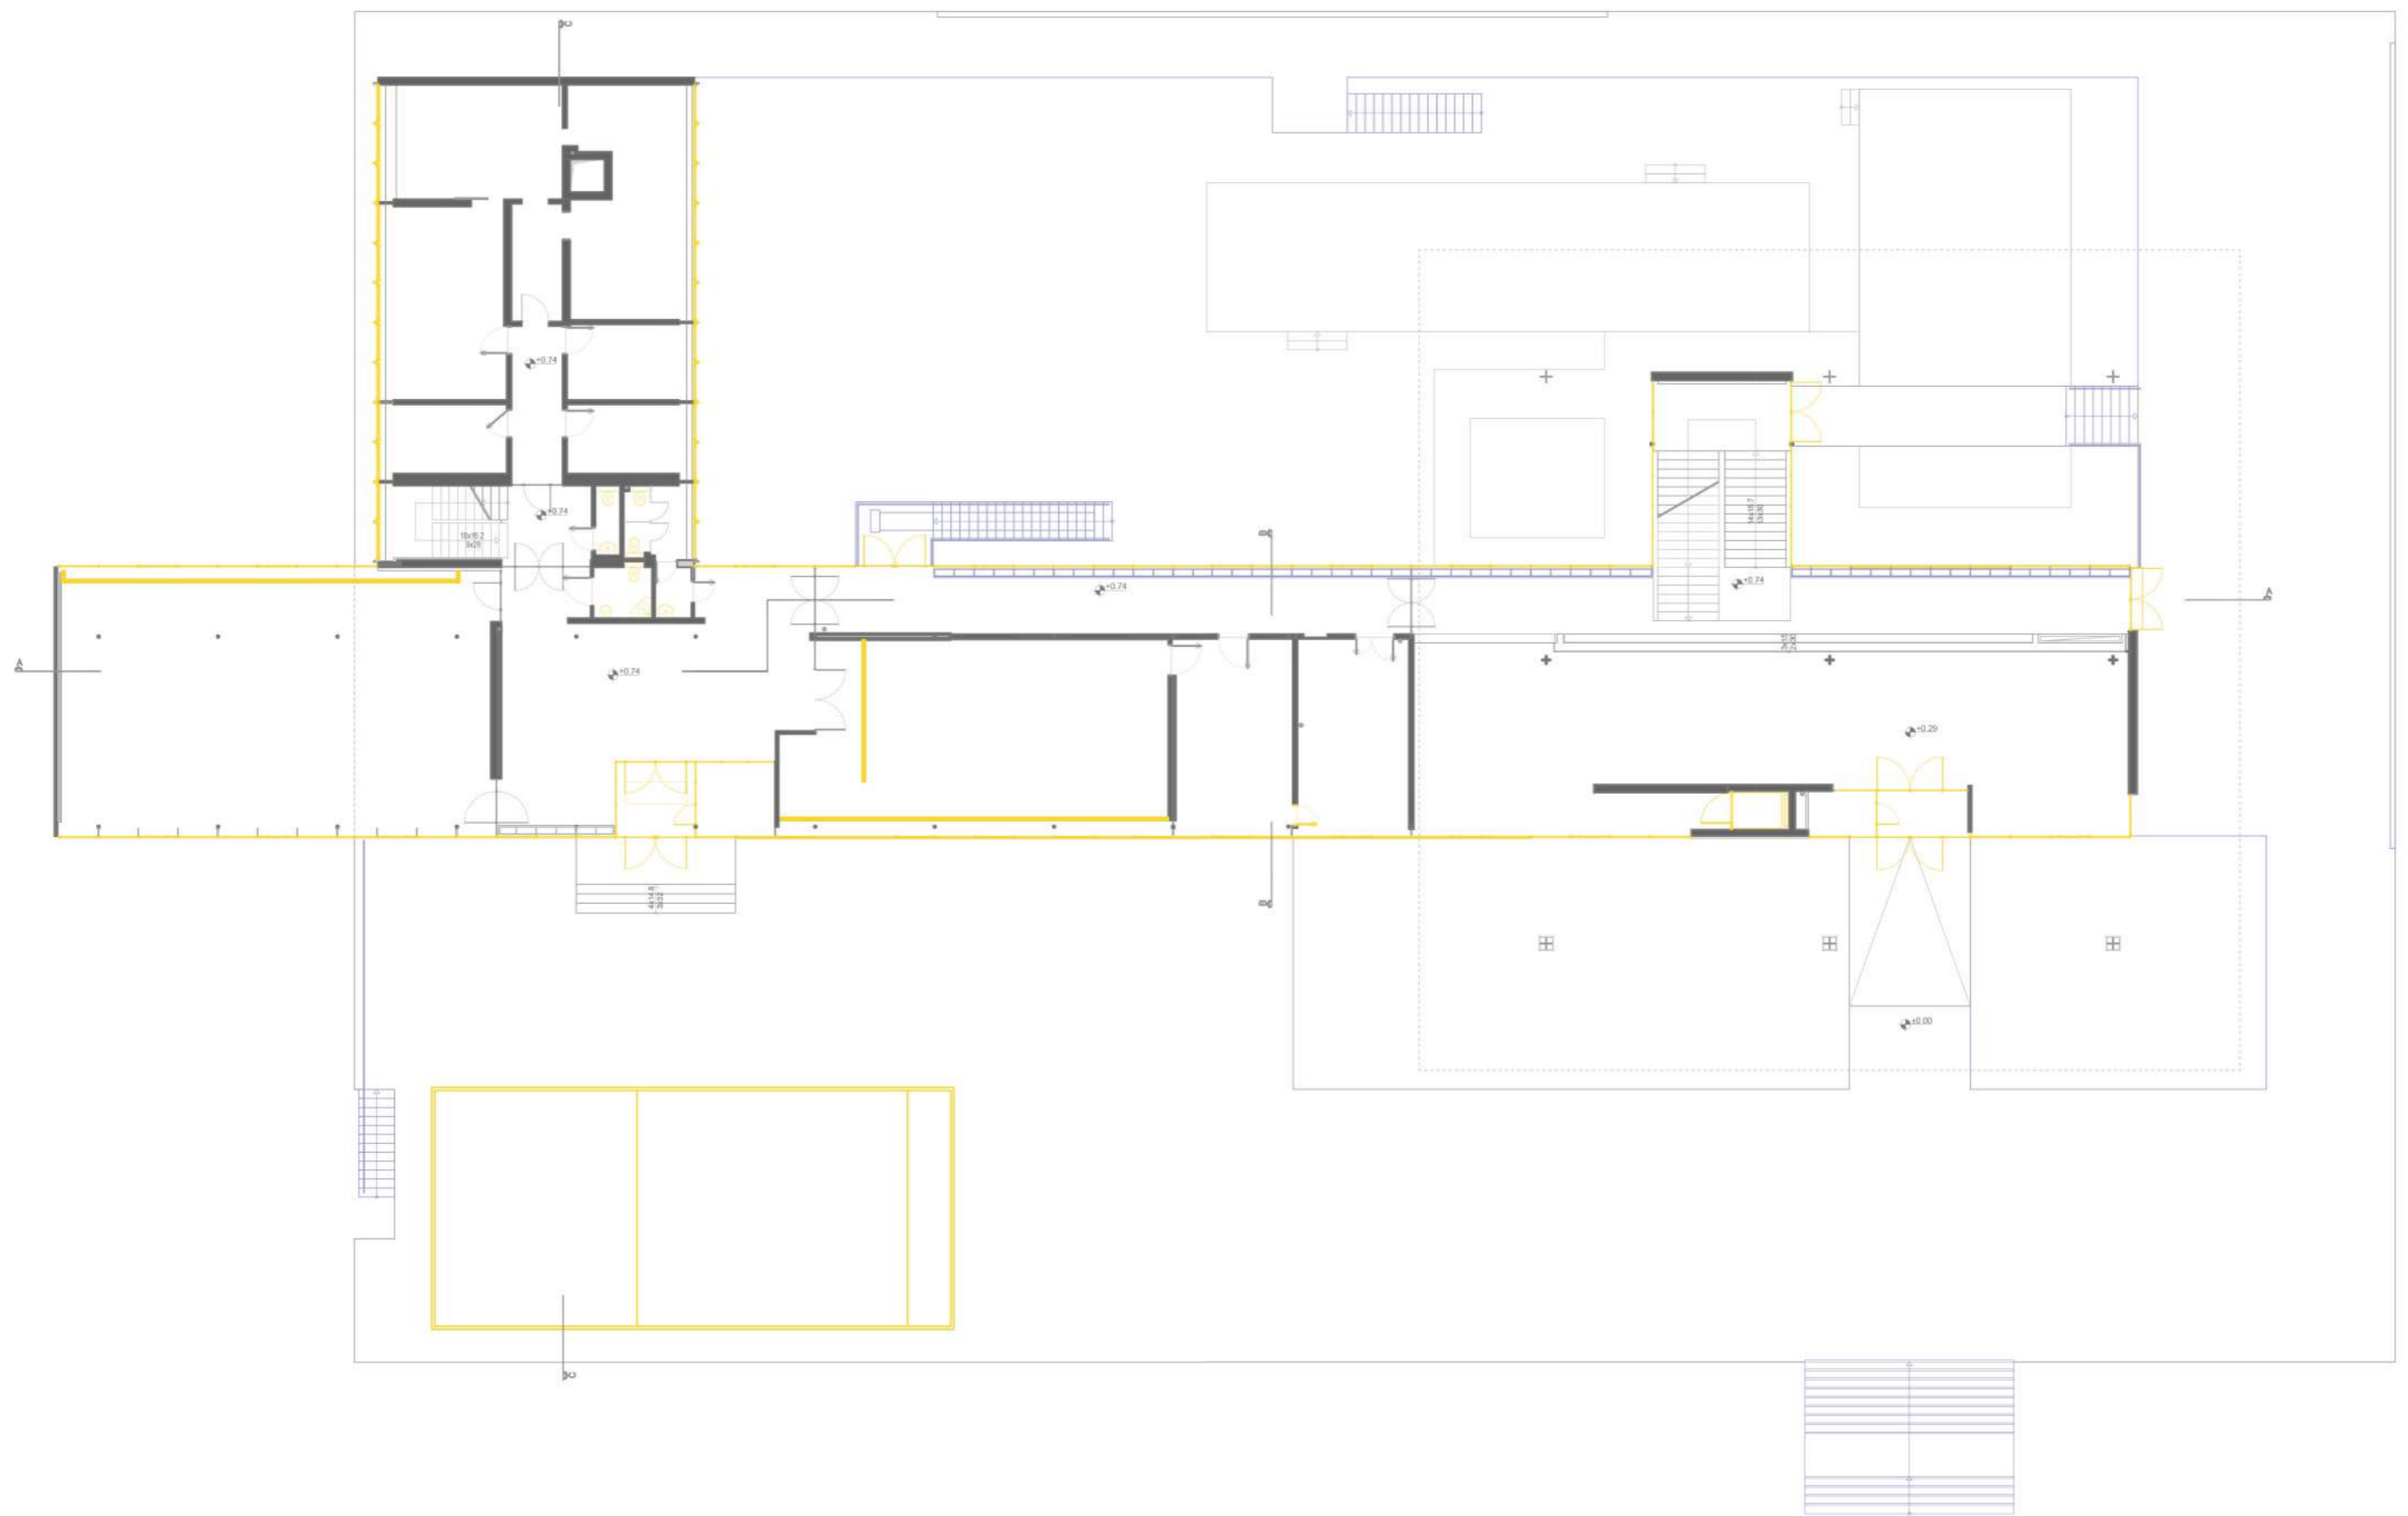
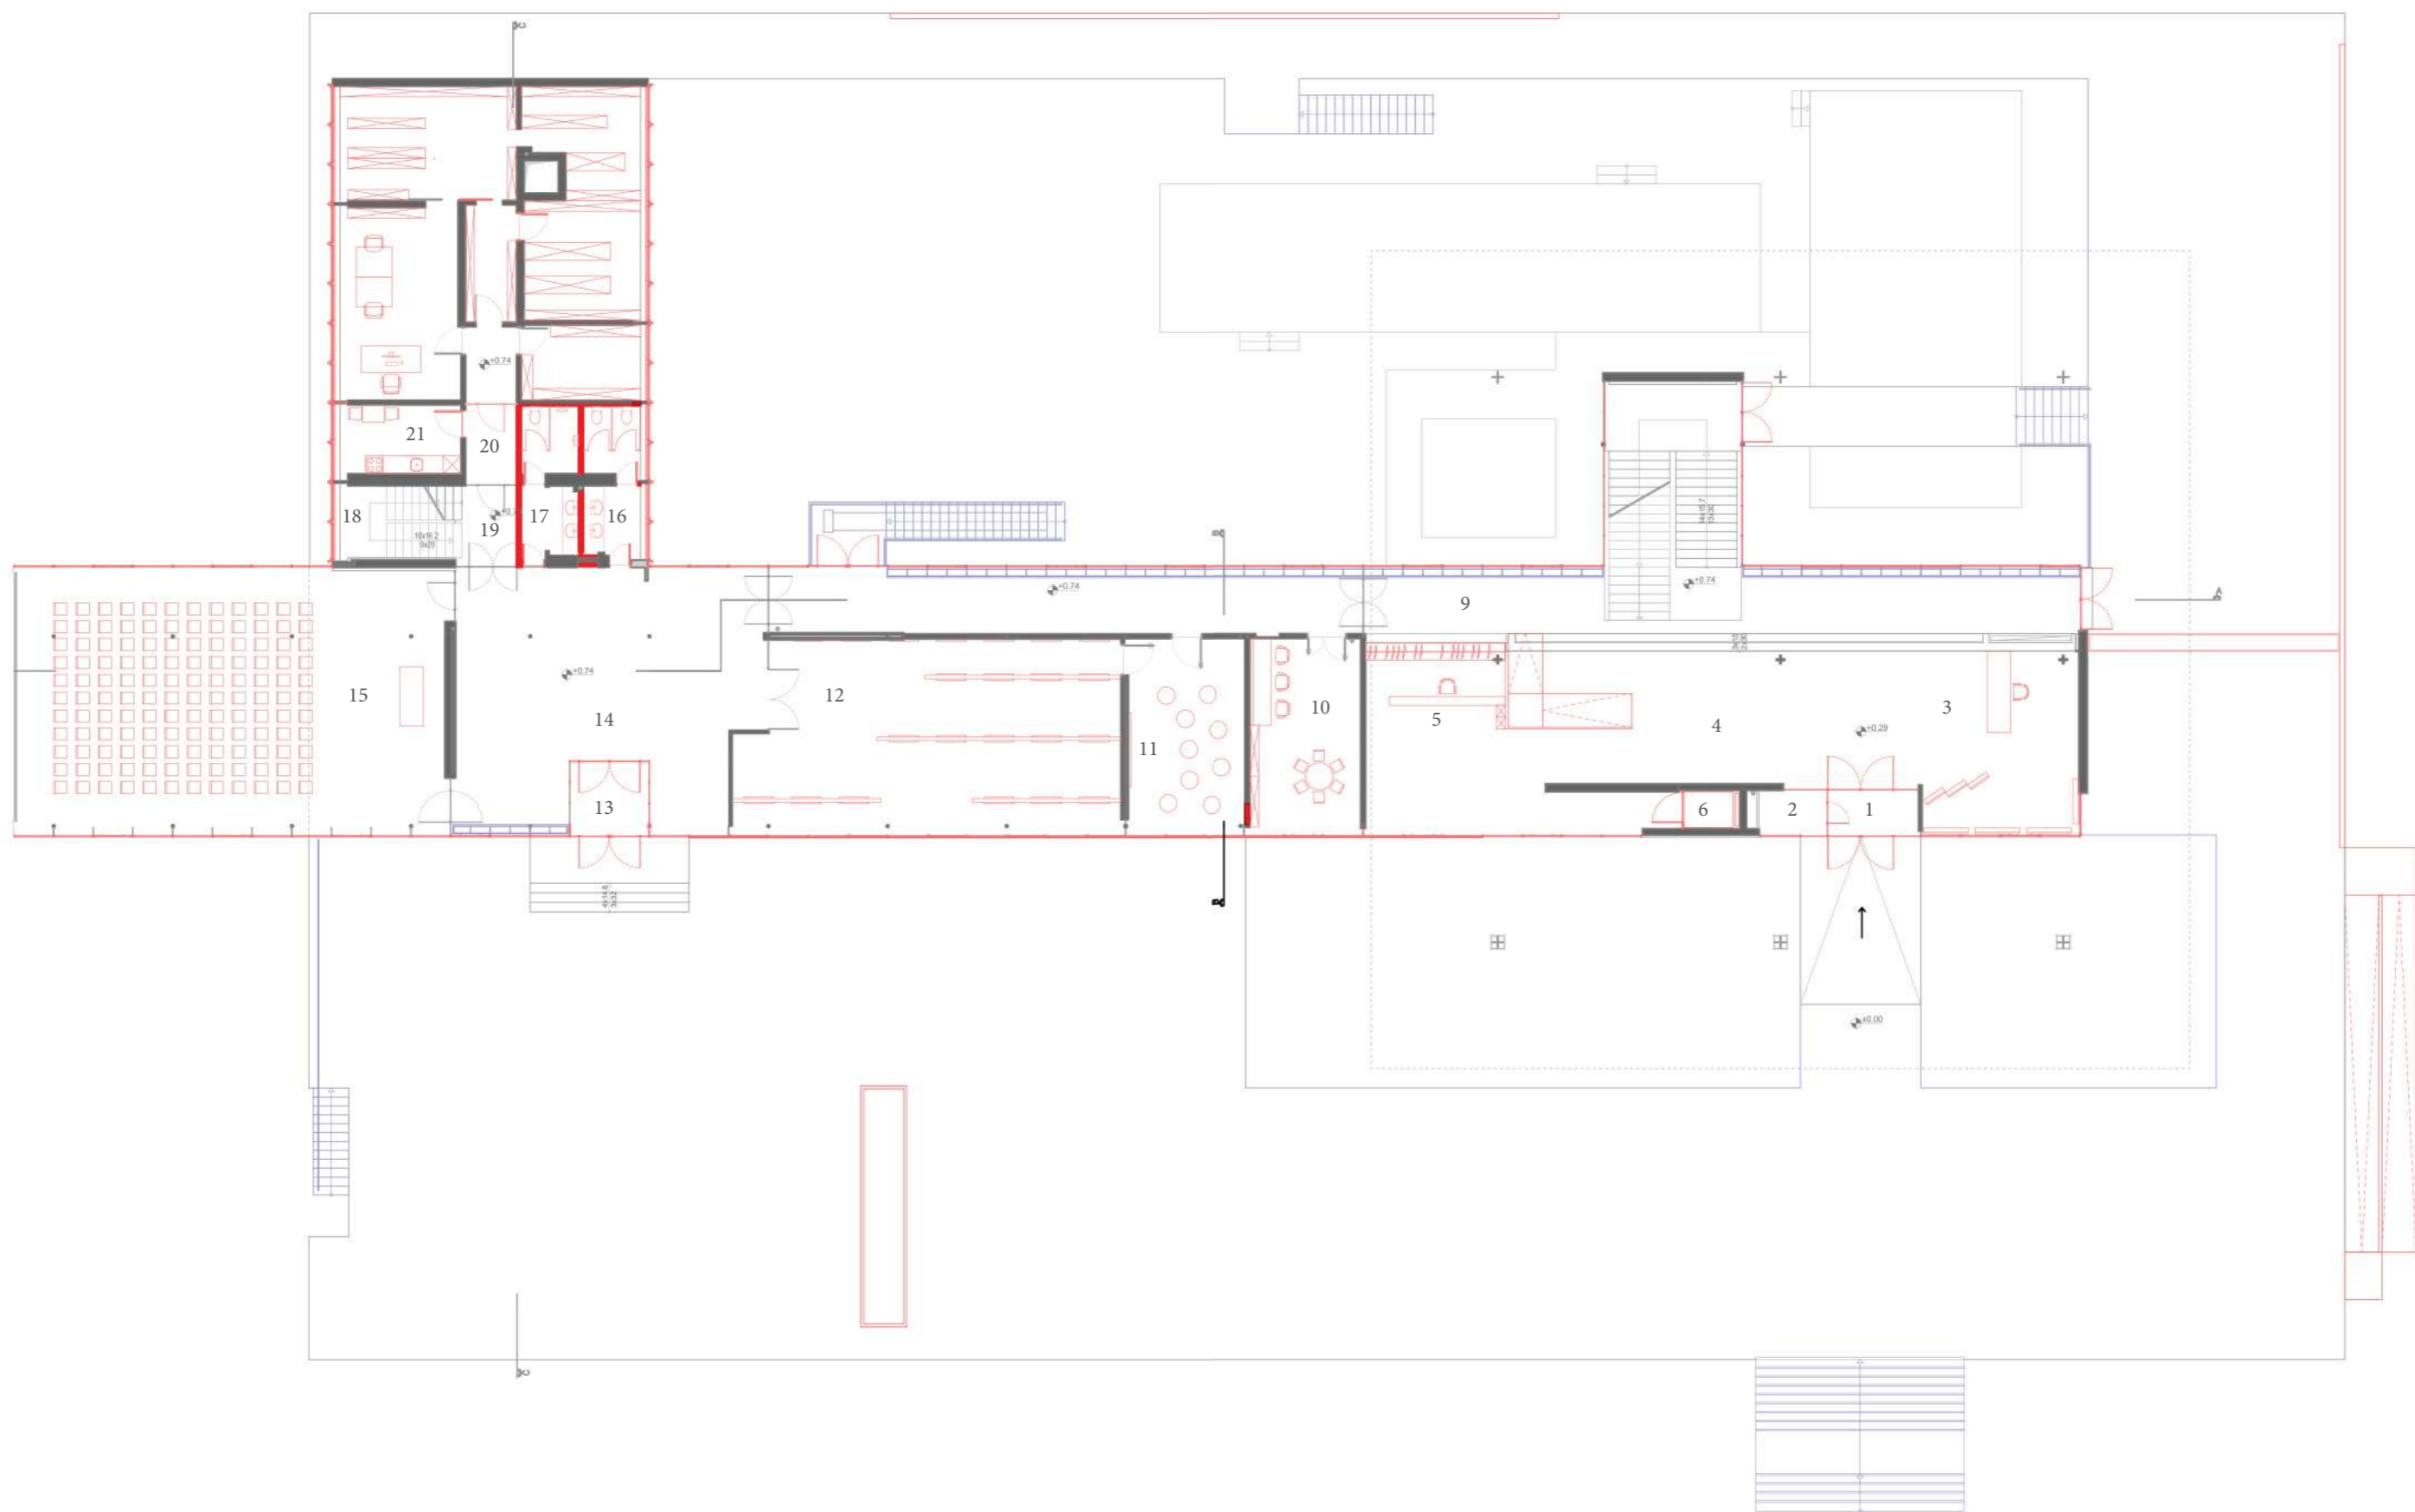
## Ground Floor

No	Name	Area (m2)
1	Windbreak	4,61
2	Doorman	3,97
3	Reception and Souvenirs Area	32,39
4	Exhibition Area 1	100,56
5	Cloakroom	13,58
6	Lift	2,49
7	Hall	146,53
8	Cloakroom	24,61
9	Catwalk	44,76
10	Informative storytelling screens room and children's corner	24,61
11	Screen viewing room 26,25	
12	Exhibition Area 2	73,32
13	Windbreak	6,52
14	Exhibition Area 3	65,59
15	Exhibition Area 4	123,73
16	Toilet 1	9,28
17	Toilet 29,23	
18	Staircase	9,96
19	Podium	7,67
20	Hallway	9,11
21	Kitchenette	9,50
23	Reading room	25,95
24	Library	51,64
25	Hallway	6,80
26	Library	28,79
27	Digitalization room	10,13

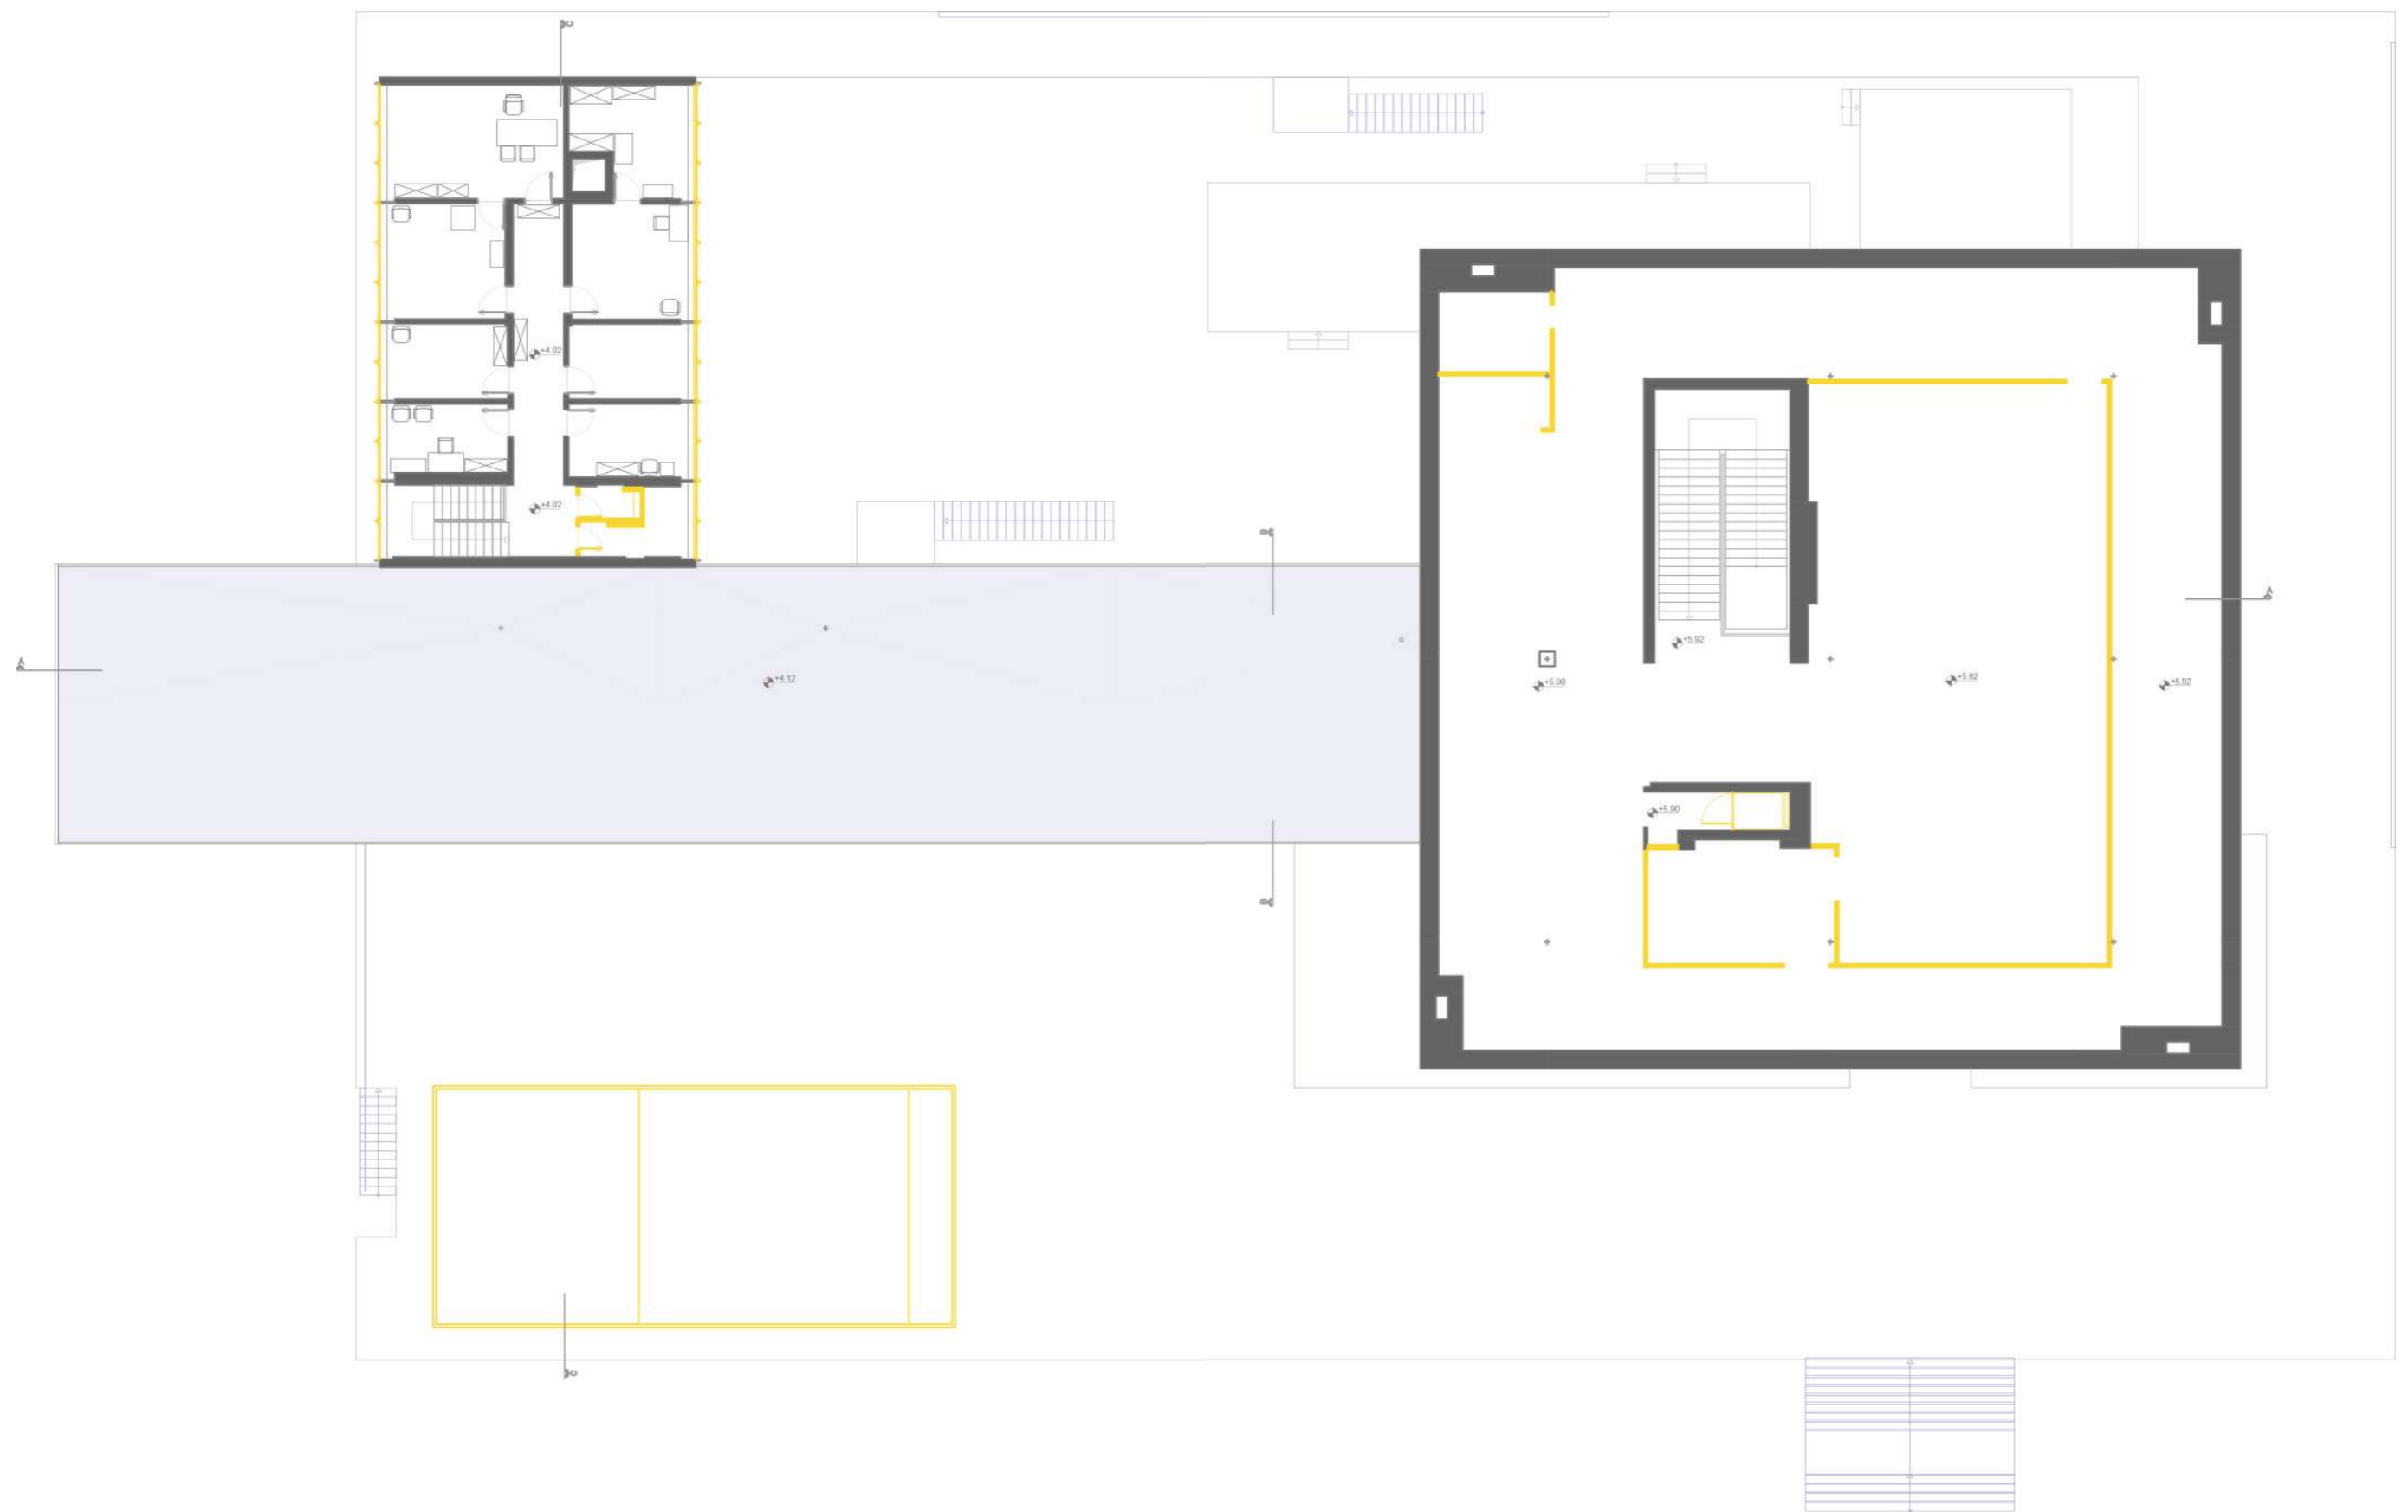
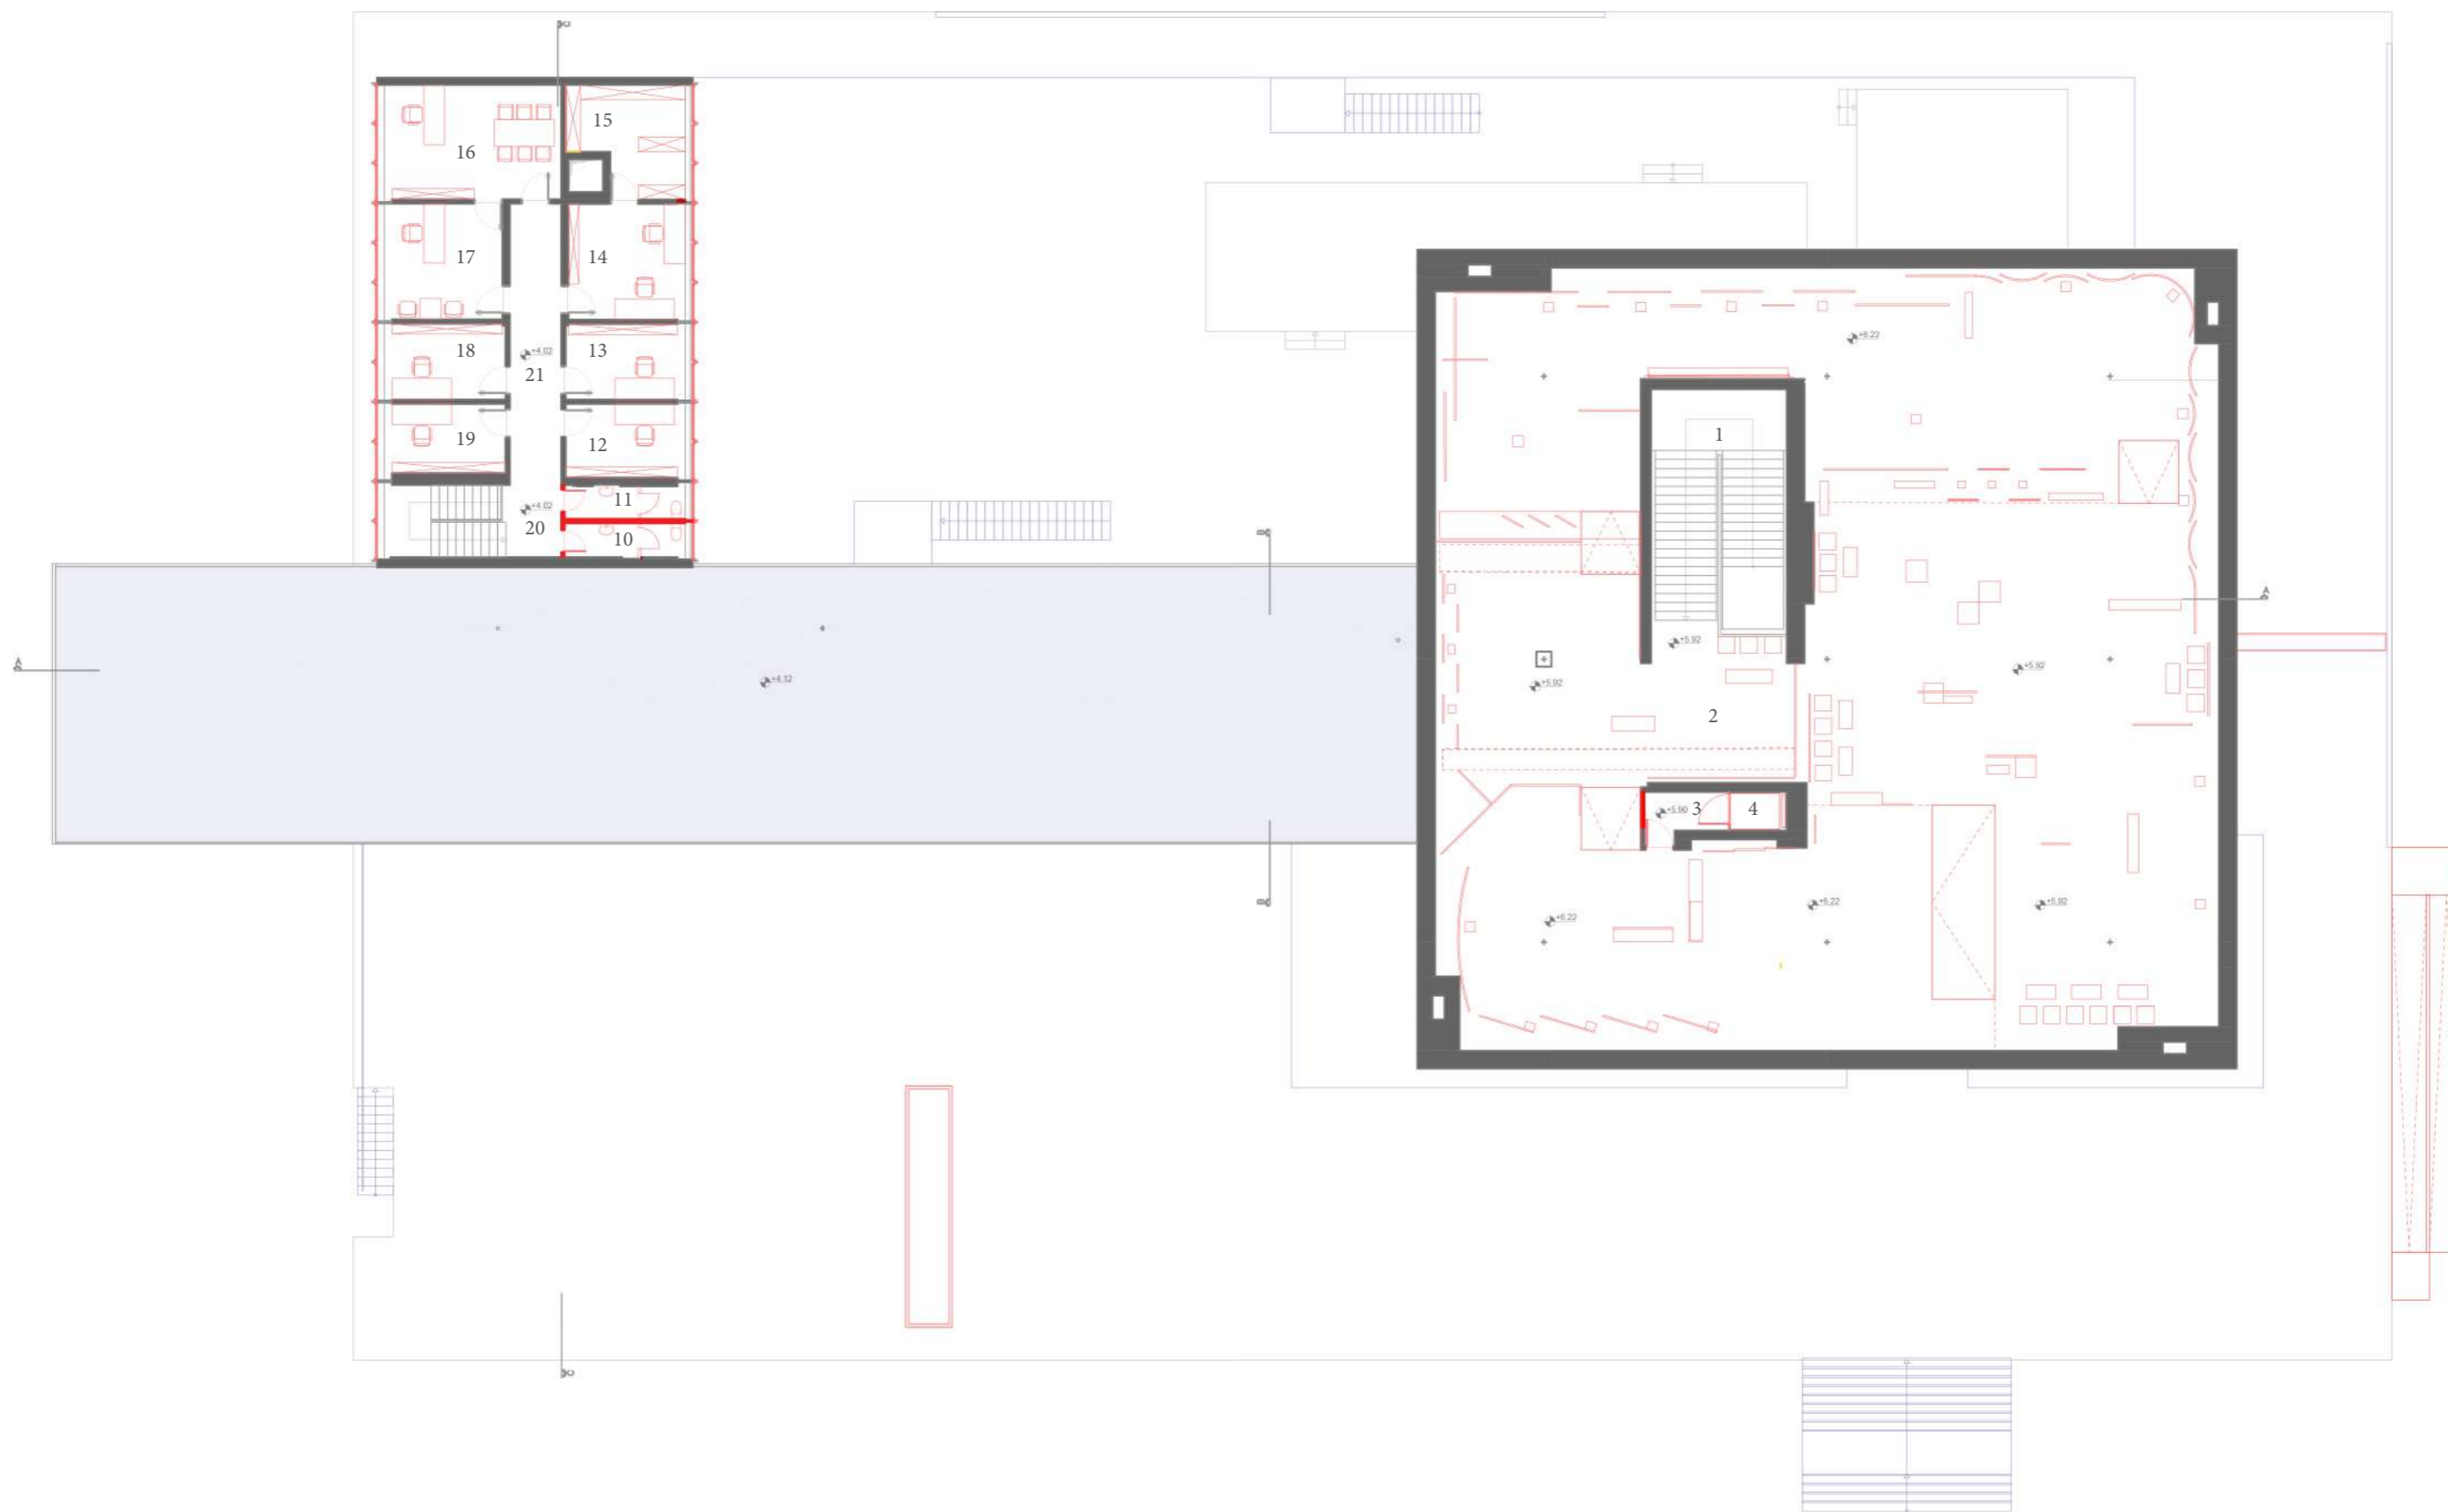
**First Floor**

No	Name	Area (m2)
<b>Cube</b>		
1	Staircase	41,86
2	Exhibition area (restored old flexible appearance; with possibility of multimedia interactive exhibition)	598,78
3	Vestibule	4,46
4	Lift	2,49
<b>Administrative part</b>		
10	Toilet 1	4,63
11	Toilet 2	4,38
12	Office 1	13,67
13	Office 2	10,79
14	Office 3	16,11
15	Current Archive	9,96
16	Director's office	23,44
17	Office 4	15,89
18	Office 5	10,41
