The Historical Museum of Bosnia and Herzegovina: Preservation of a  
Modernist Gem In Sarajevo

Department of Architectural Conservation

Czech Technical University in Prague | Faculty of Architecture

**DIPLOMA PROJECT**

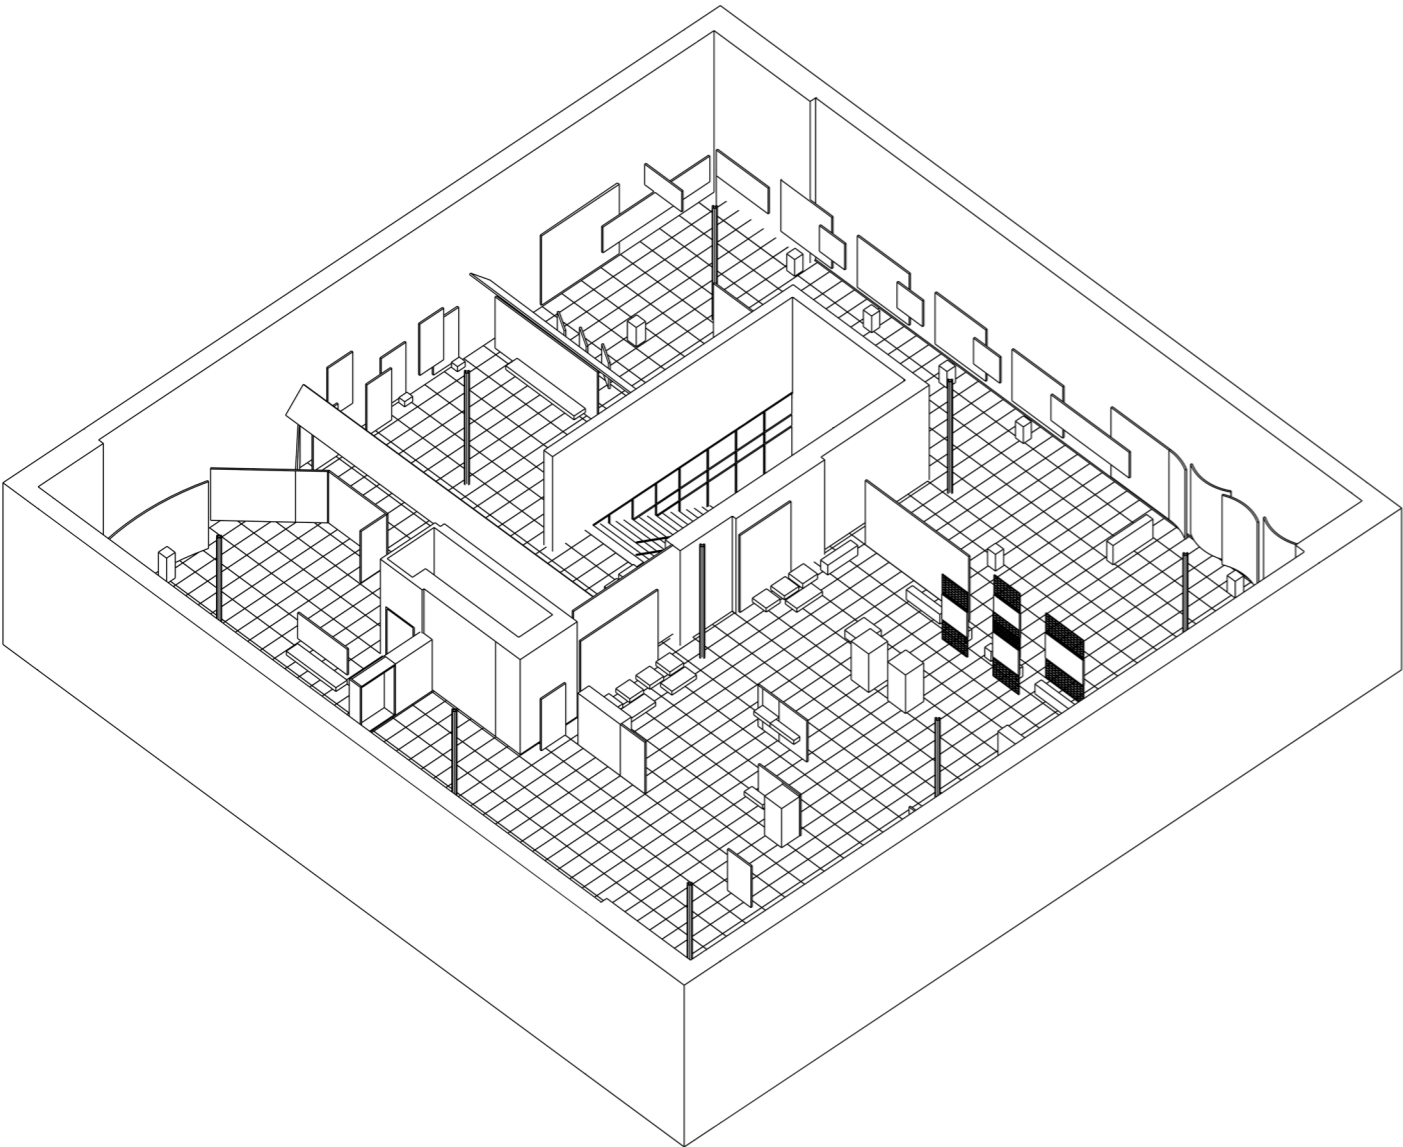
Schematic representation of the interior of the main exhibition part according to original drawings, but still providing flexibility for more contemporary exhibits.
