# RECONSTRUCTION STRATEGY AND DESIGN

## FOR NORTHERN SALTIVKA, KHARKIV

DIPLOMA PROJECT

Studio Achten - Pavliček Czech Tecnical University in Prague Faculty of Architecture and Urbanism SS 2024/2025 Author: Kateryna Natalchuk

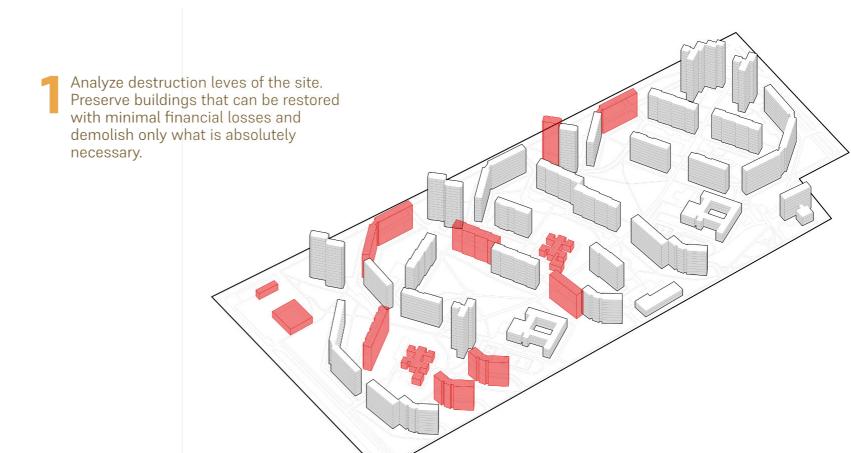
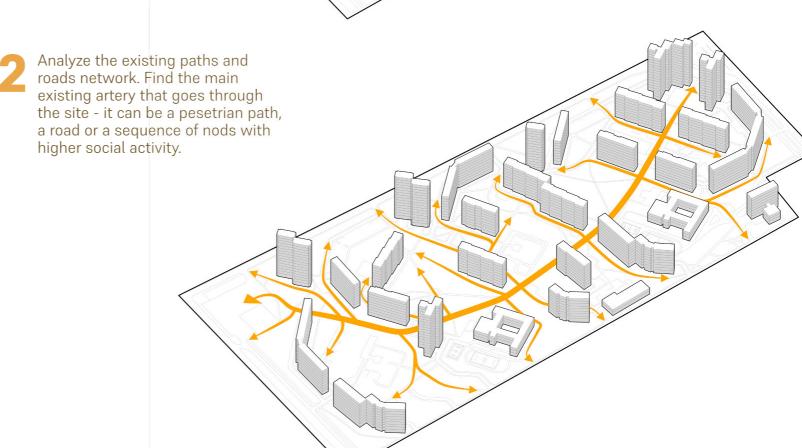
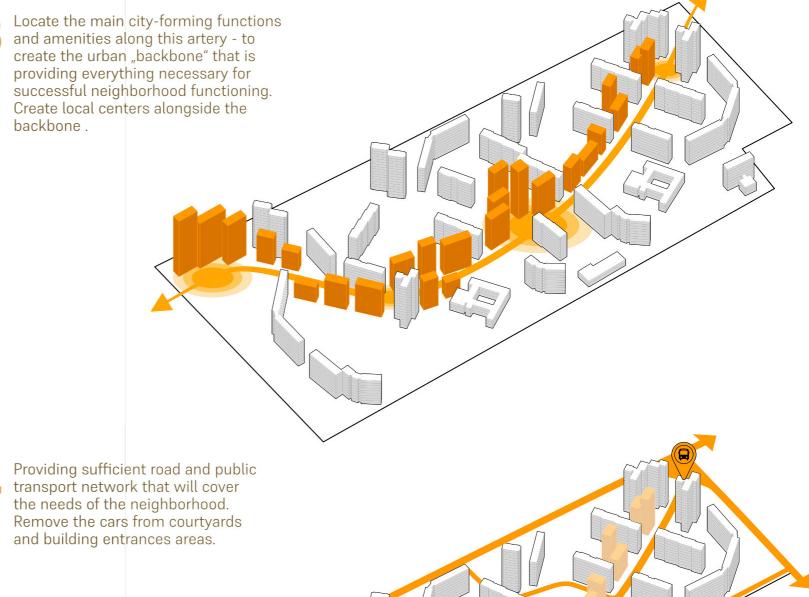
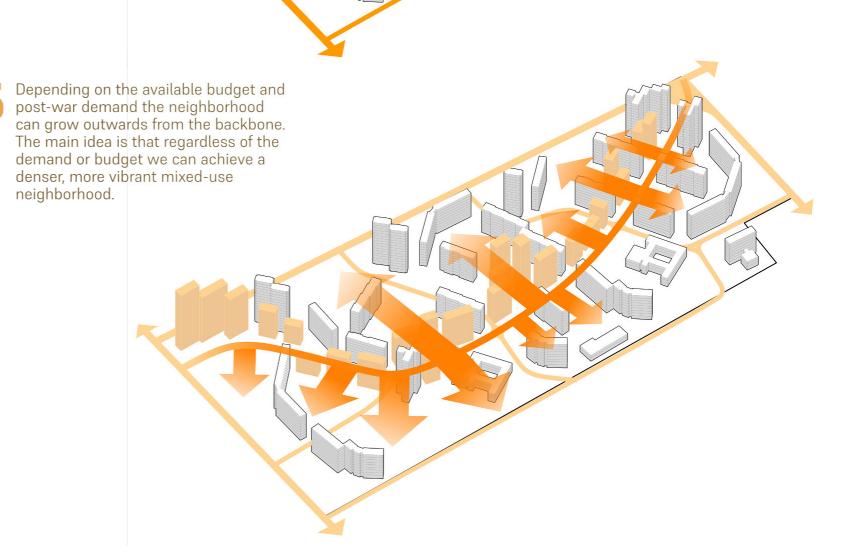
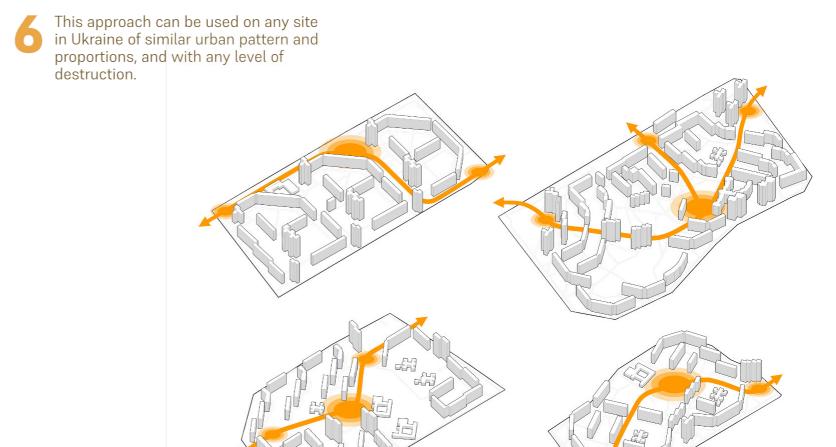
### SEVERE DESTRUCTION **ANALYSIS**

insignificant damage of outer layers of facade without structural damage broken windows and balcony doors

minimal structural damage on balconies

mass replacing of destroyed windows and balconies removing the burned layer of facade

covering the facade imperfections with the mortar using crushed concrete from repainting the facade

## MEDIUM

facade that was burning for not prolonged period of time and no significant structural damage is visible missing whole upper floors, missing large areas in the middle of the building

some sections are missing but are possible to replace as the rest of the building is intact

holes in the facade that are possible to fix

replacing fire damaged facade panels with the new ones using steel reinforcement fixing holes in the facade with the mortar using crushed concrete from demolished buildings

big areas of prefab panels that are no longer functioning as a load-bearing elements

facade that was burning for prolonged period of time and is showing clear structural damage
